Building Explosion and Fire
Silver Spring, Maryland
August 10, 2016

Accident Report

NTSB/PAR-19/01
PB2019-100722

Pipeline Accident Report

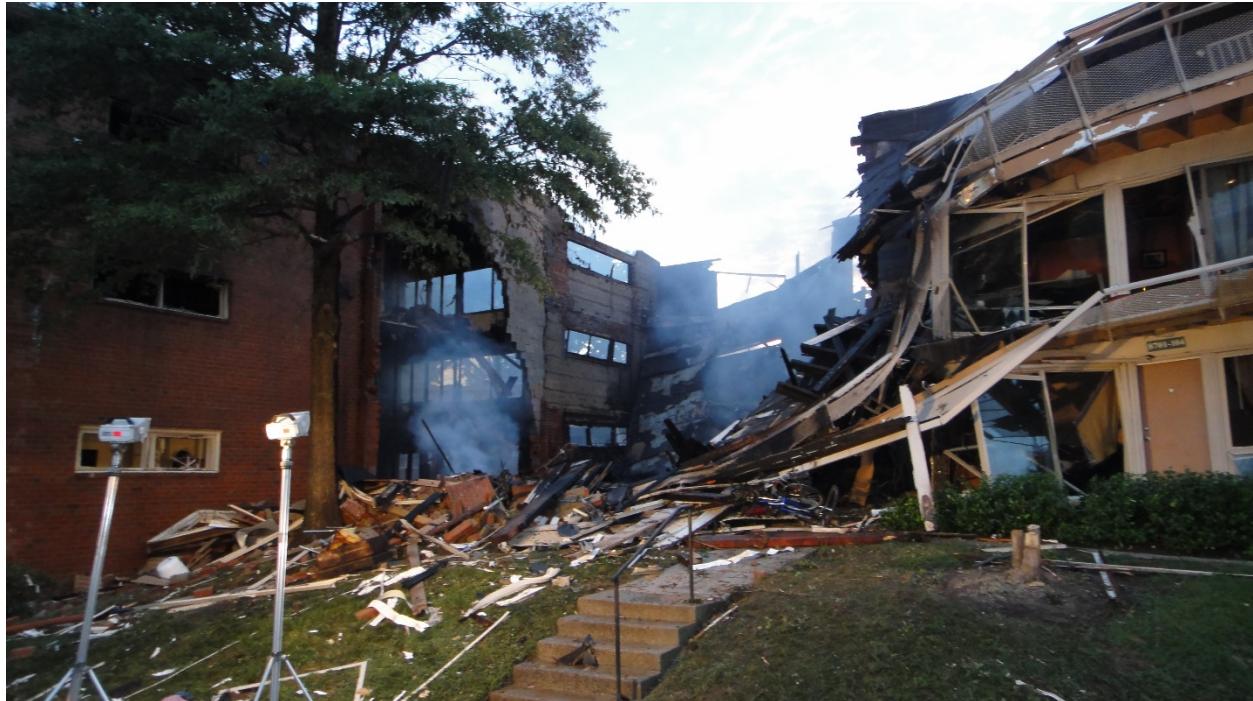
The explosion and fire also heavily damaged an adjacent apartment building, 8703 Arliss Street, which shared a common wall with building 8701. (See figure 2.)

Figure 2. Buildings 8701 (right-center) and 8703 (left) Arliss Street, Silver Spring, Maryland, after the explosion and fire. (Photograph provided by the Public Service Commission of Maryland.)

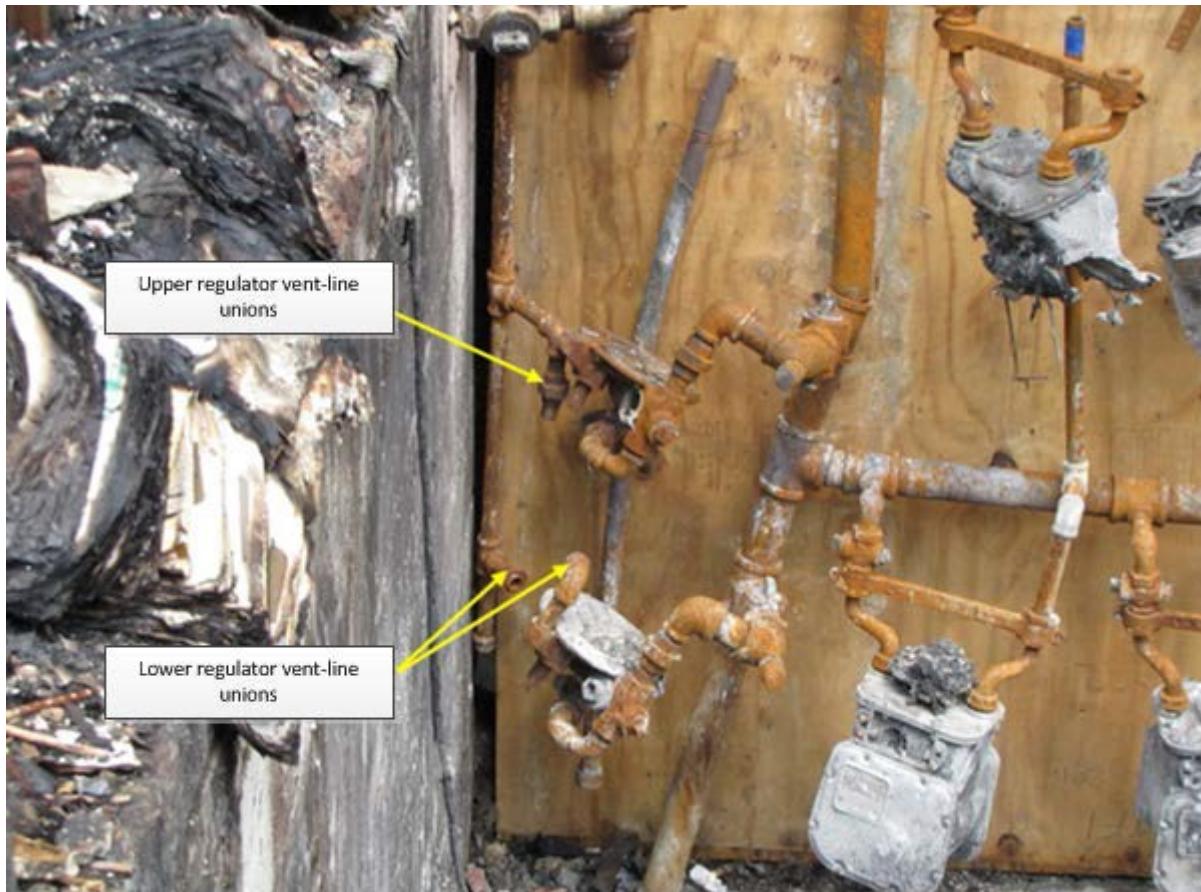
NTSB focused on the gas service equipment and appliances in the meter room because the ATF's investigation ruled out all other potential fuel sources in the room and the evidence indicates that the explosion originated in the meter room. During the inspection of the basement level of building 8701, NTSB investigators found burned and damaged components of the gas meter assembly, which included the mercury service regulators. A detailed inspection revealed that the vent line connection to the upper mercury service regulator was fractured below the coupling/union assembly, and the lower mercury pressure regulator was not connected to the regulator vent line at the coupling/union assembly, as shown in figure 5.²⁴

Figure 5. Portions of mercury service regulators and gas meters in building 8701 showing heat/fire/explosion damage and the unconnected lower regulator vent line.

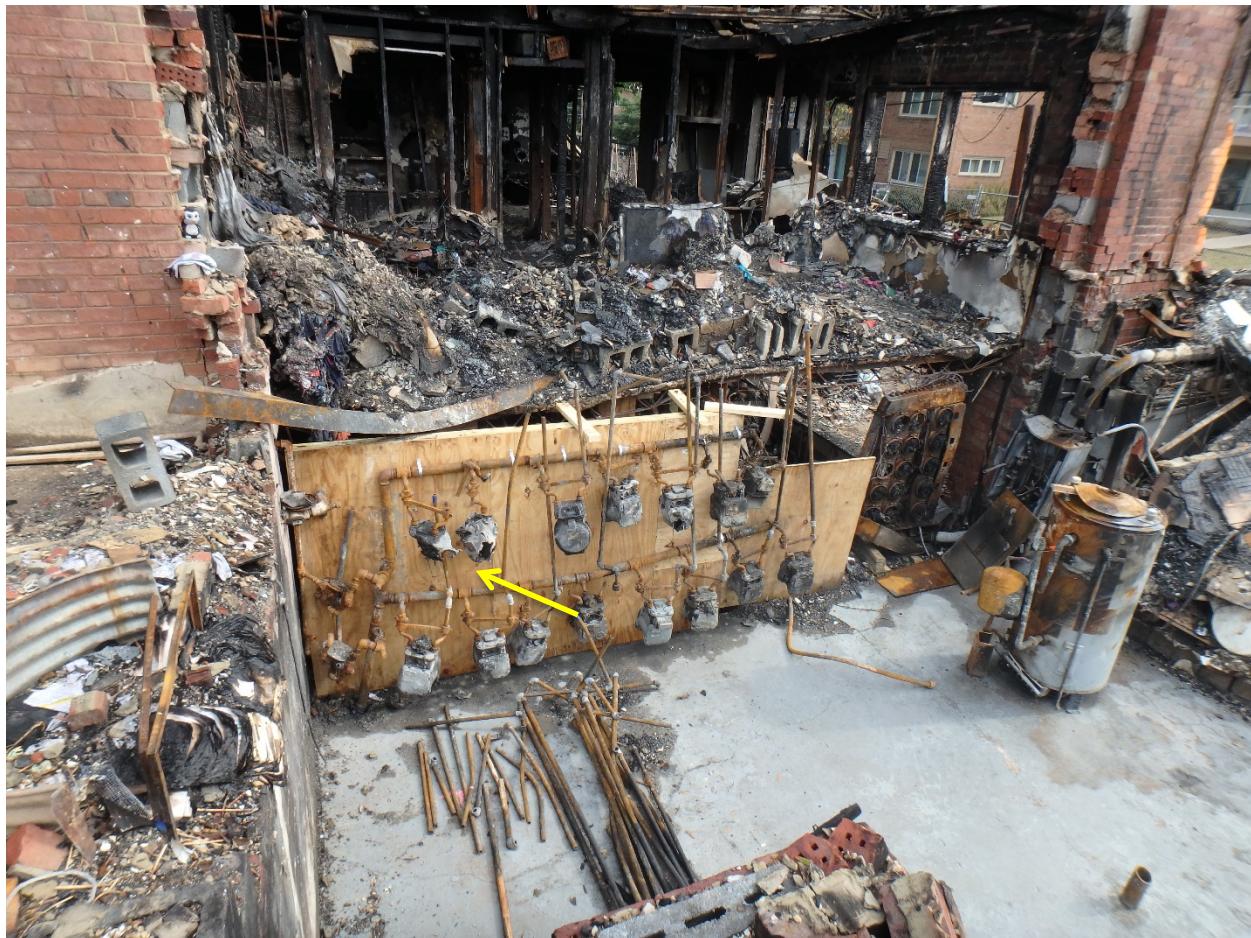
ATF reconstructed the natural gas meter rack, piping, electric meters, and water heater. The gas meters on the upper row of the meter rack near the regulators showed significant fire and heat damage, particularly when compared with the gas meters farther away from the point of the explosion at the west wall. (See figure 6.) The water heater showed significant fire and heat damage and was found in the northeast quadrant of the meter room, about 6 feet from the nearest customer gas meter. The water heater was placed by ATF at its pre-explosion location.

Figure 6. Building 8701 after debris removal and ATF reconstruction. The first two gas meters (designated with a yellow arrow) show substantially more heat/fire damage than other meters. (Photograph provided by ATF.)

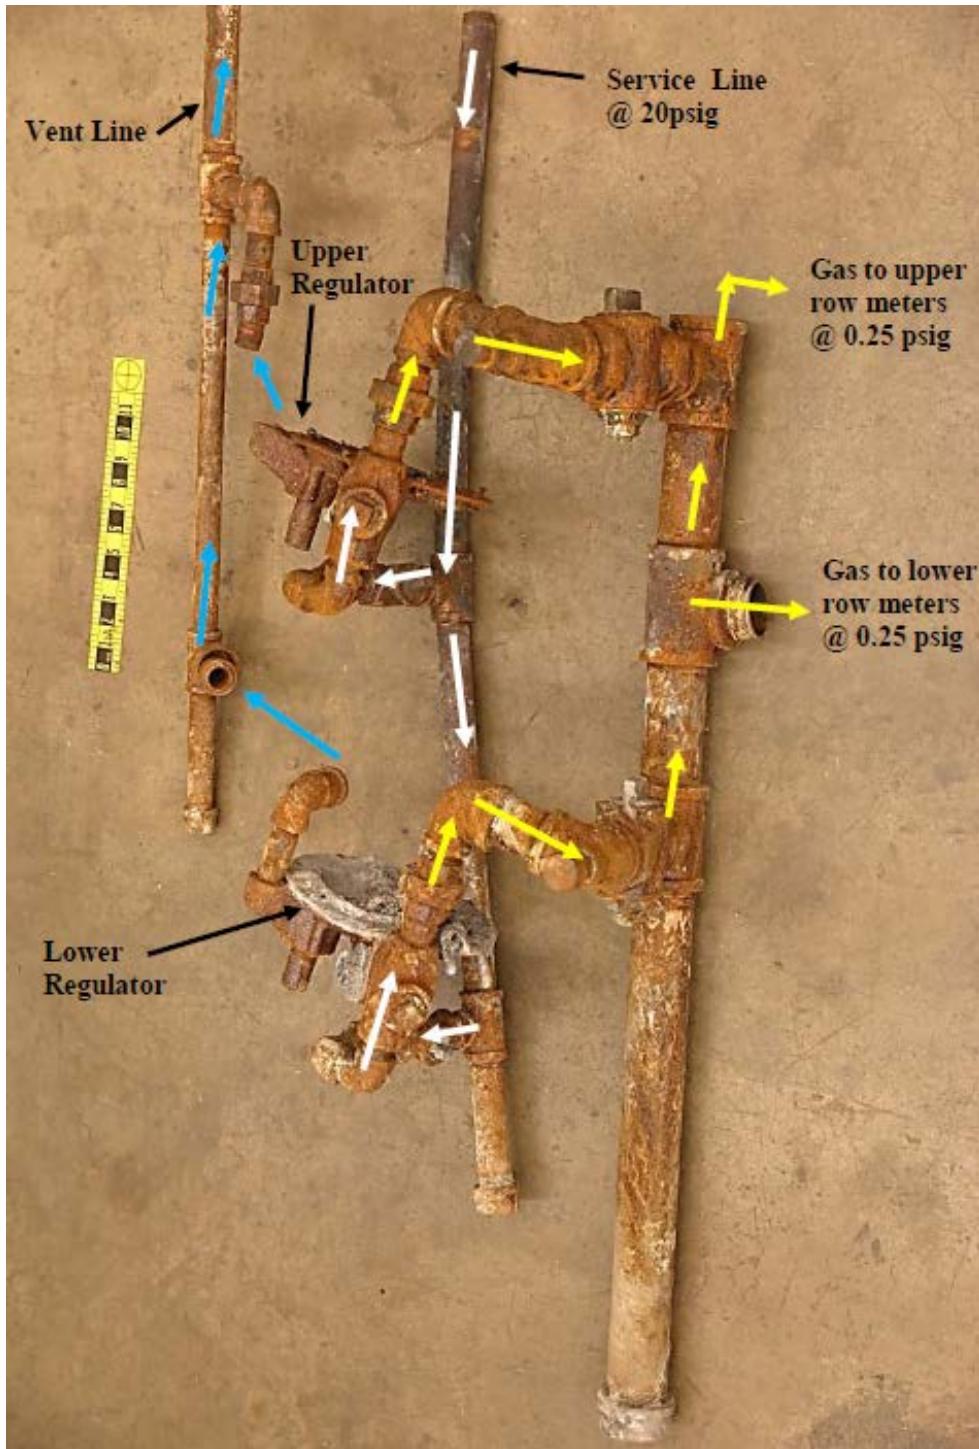
Figure 10 is a photograph of an approximate reconstruction of the preaccident configuration of the service regulators, service line, pipeline to the meters, and vent line. The white and yellow arrows pictured show the direction of the gas flow through the service line during normal operation; the blue arrows show the direction of the gas flow under an over-pressure scenario through the vent line.

Figure 10. Mercury service regulators, service line, jurisdictional pipeline, and vent line after the accident.

Investigators from the NTSB Materials Laboratory performed a compositional alloy analysis on the mercury service regulators from the affected buildings and determined that the body was made from a ferrous alloy, and the top cover and metal tags were made from an aluminum alloy. The melting temperature of a typical aluminum alloy is about 1,220°F

(Moses 1978). The top cover and 2-inch diameter plug for the upper and lower gas regulator assemblies were both melted from exposure to heat from the fire.²⁸ Based on this observation, the temperature in the general area of the gas regulator assemblies reached at least 1,220°F. This also explains why mercury was not found in the reservoir cups of the upper and lower gas regulator assemblies. Mercury exists as a liquid at room temperature and has a boiling point of about 674°F, where it evaporates. The mercury most likely evaporated as a result of heat exposure from the fire.

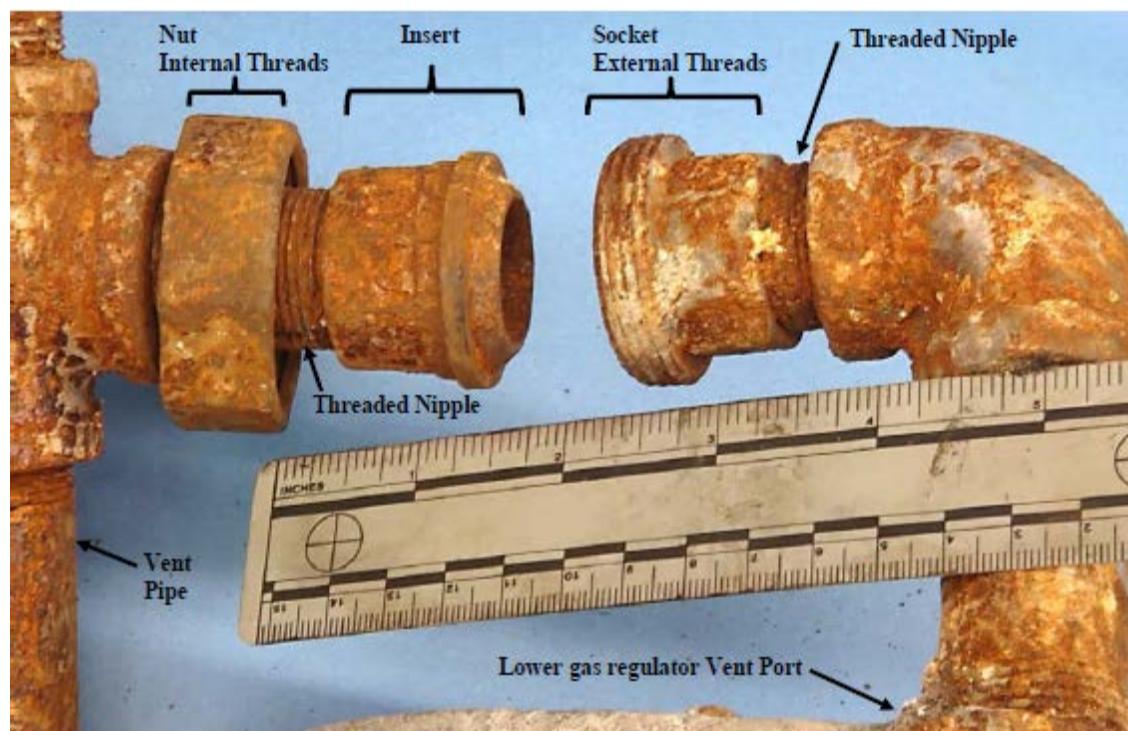
The two regulators that serviced building 8701 were connected to one vent line, but each regulator had its own union assembly. A union assembly is made up of three components: an internal threaded nut, an insert, and a mating external threaded socket. Figure 11 shows a photograph of the lower regulator union assembly parts before cleaning. The separation was between the internal threaded nut (on the left) and the external threaded socket (on the right) of the lower assembly.

Figure 11. Photograph of the lower regulator union assembly parts (before cleaning).

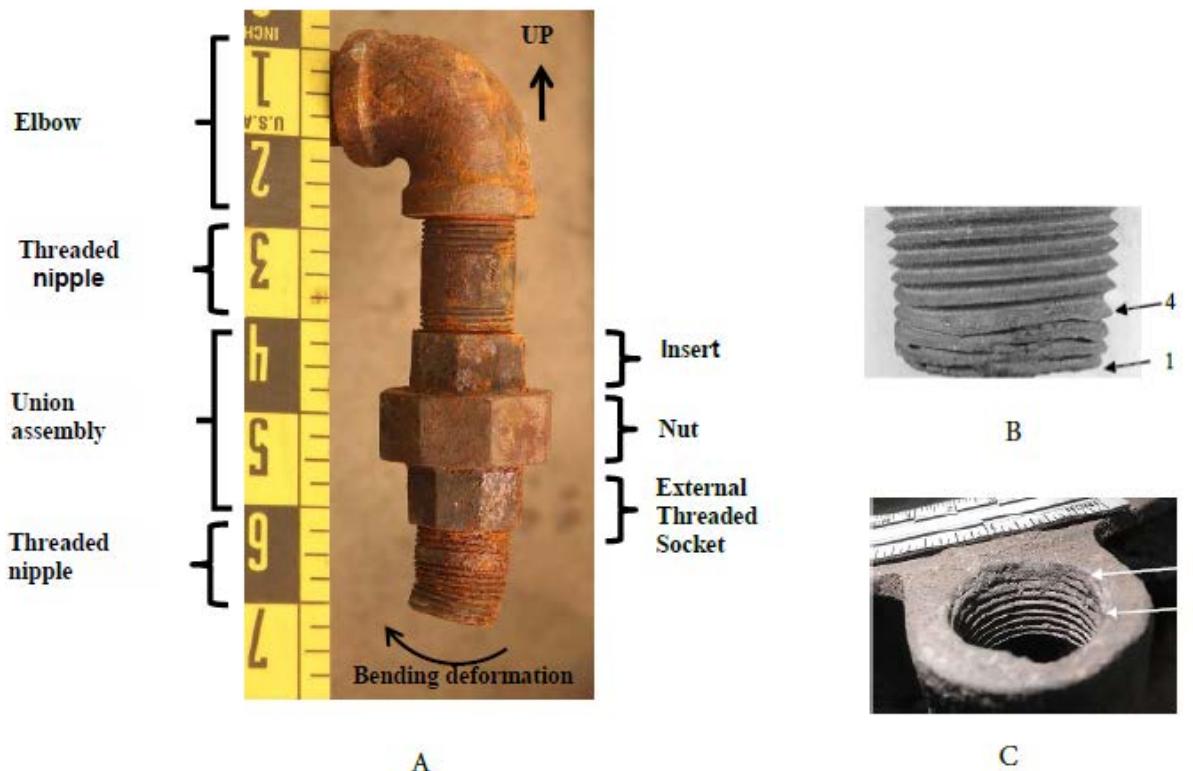
as shown in figure 12-C, showed thread damage that coincided with the damage observed on the nipple. (See figure 12-B.) The observed damage is consistent with the damage that could occur if the threaded nipple was forcefully pulled out of the mating regulator vent port.

Figure 12. A photograph of the exposed external threaded nipple from the upper regulator union assembly.

NTSB investigators felt a slight looseness between the nut and insert portion when trying to disconnect the union assembly between the nut and the external threaded socket; however, the union assembly could not be rotated by hand. (See figure 12-A.) This indicated that the hermetic seal between the ball portion of the union external socket and the nut was broken.²⁹ This was confirmed by a pressure test of the union assembly, which showed a leak at the nut and external thread on the socket. The damage to the hermetic seal likely occurred from the force of the explosion or intense heat exposure from the fire.

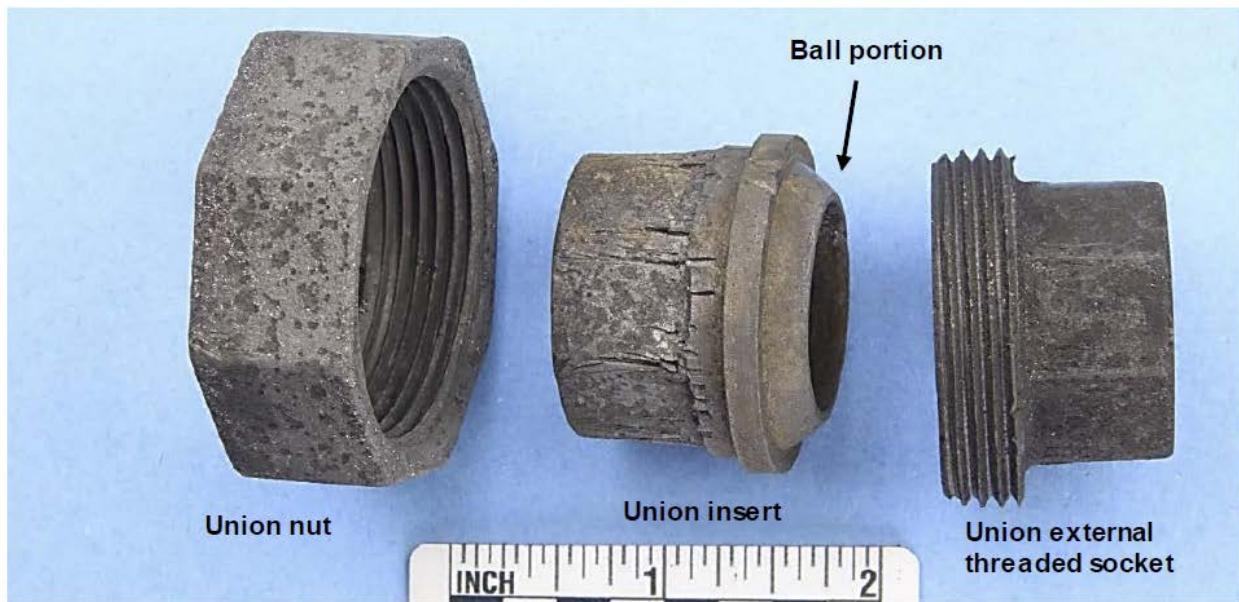
Figure 13 shows the union assembly components after cleaning. The external threads of the socket contained two dents; and the crown portion of the first two full external threads of the socket showed minor deformation.³⁰ The external threaded socket showed no evidence of major deformation. On one side of the nut, the crown portion of the first three internal threads showed evidence of minor metal flow deformation; and NTSB investigators observed similar deformation on an isolated area of only one thread on the diametrically opposite side. When mating threads are pulled apart by force, fracture or deformation by shear of the threads can also be expected.³¹ However, NTSB investigators observed no evidence of deformation or fracture of the threads in the nut and corresponding mating threads on the socket (compare figures 12 and 13 for thread damage). Had the force of the explosion, falling debris, or a building collapse caused the disconnection of the lower union assembly, there would be evidence of mechanical damage or deformation through a significant portion of the engaged threads, as seen with the threaded nipple for the upper regulator union assembly.

Figure 13. Photograph of the disassembled union assembly for the accident lower gas regulator after cleaning.

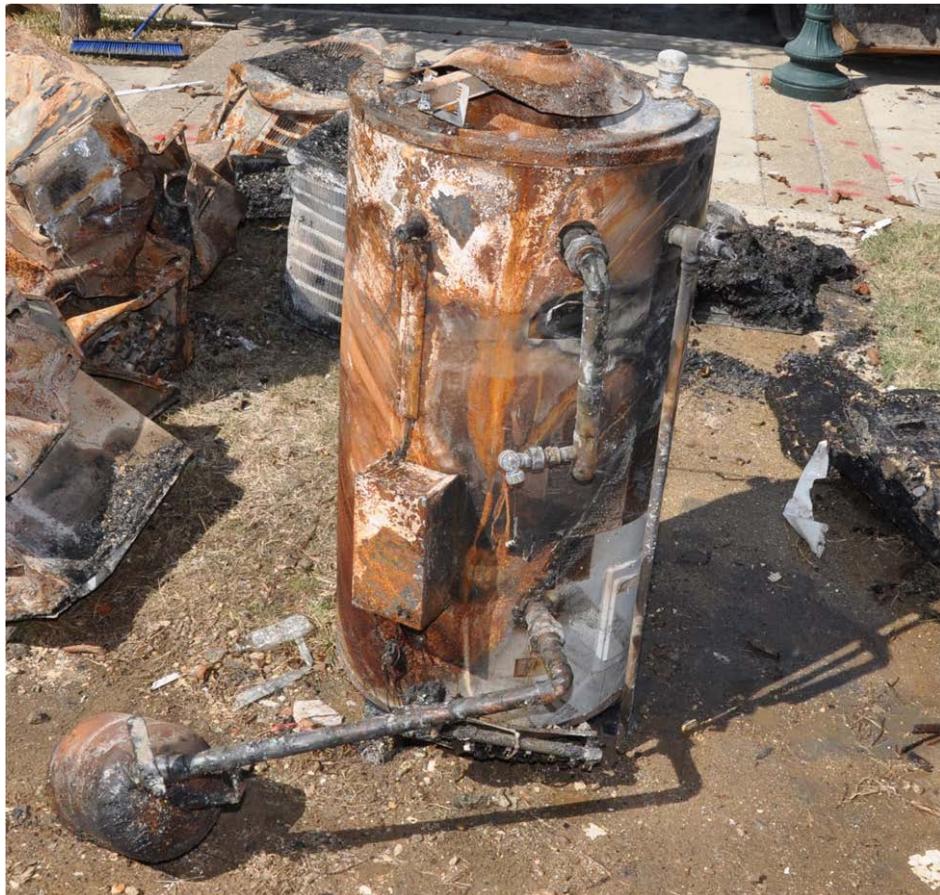
In a postaccident examination, NTSB investigators observed that nearly half of the water heater was covered with a U-shaped pattern of thermal damage. Visual examination of the water heater by investigators showed no evidence of bulging or significant body deformation.³⁶ (See figure 14.)

Figure 14. Hot water heater at the accident scene after the explosion. (Photograph provided by ATF.)

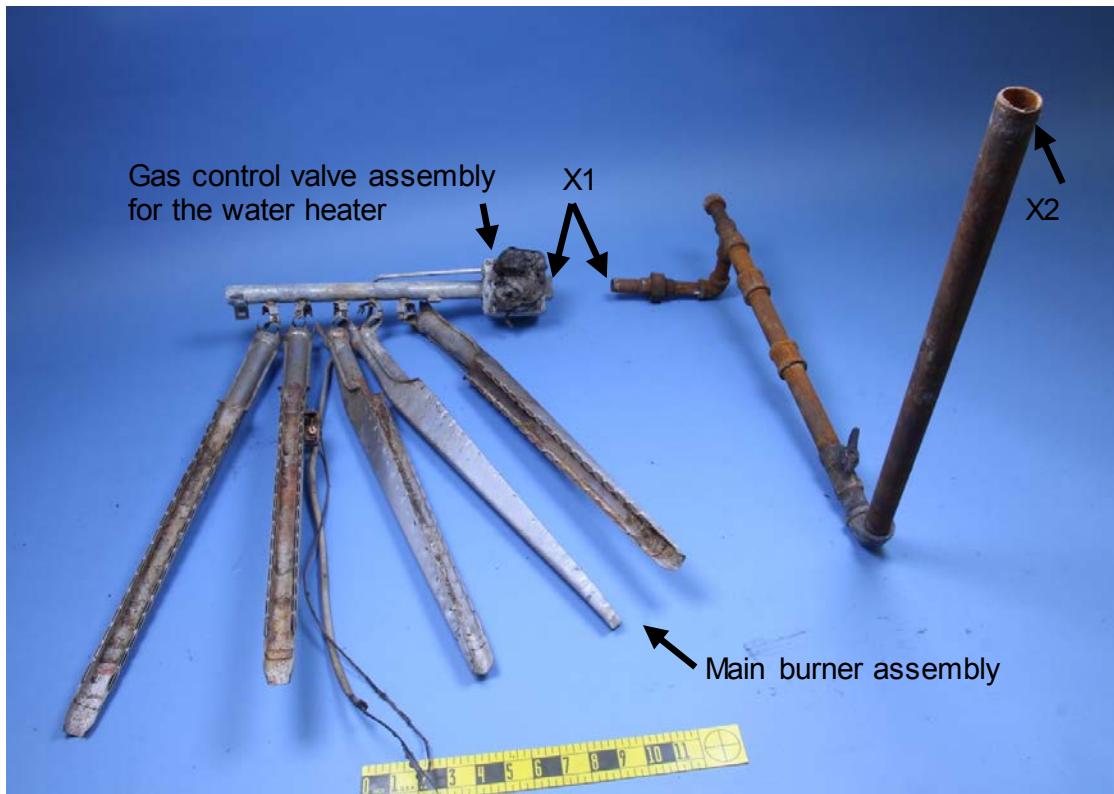
In addition, a length of gas piping, which included the gas shut-off valve, was still attached to the water heater. All the recovered piping associated with the water heater was heavily oxidized, consistent with heat exposure, and all piping connections were found to be attached and threaded completely. The recovered gas piping to the water heater had a full-diameter, through-thickness fracture at the end of the section where the piping connected to the inlet on the gas control valve assembly, near the bottom of the water heater. Figure 15 shows the main burner assembly and pipe segment that separated from the gas control valve assembly. The fractured end of the pipe segment

showed evidence consistent with an overstress separation.³⁷ Therefore, the NTSB concludes that the gas piping to the water heater was most likely separated at the control valve due to overstress forces resulting from the explosion. Furthermore, the NTSB concludes that the water heater did not fail prior to the explosion and was not the source of the natural gas release in the meter room.

Figure 15. The main burner assembly, including the separated pipe and the gas control valve assembly. The arrows labeled X1 and X2 indicate the pipe segment fractures at the threaded portion.
