Building Explosion and Fire
Silver Spring, Maryland
August 10, 2016

Accident Report

NTSB/PAR-19/01
PB2019-100722

Pipeline Accident Report

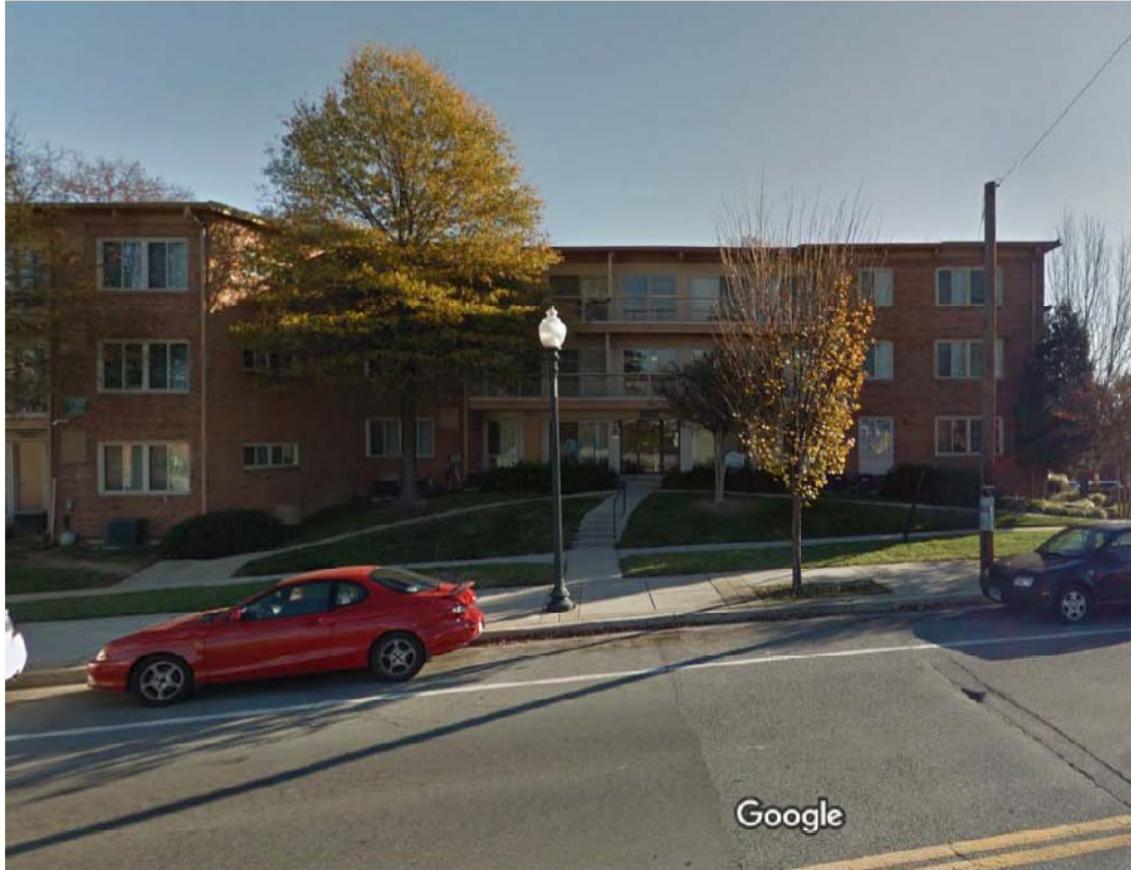
Figure 1. The accident location, 8701 Arliss Street, before the August 10, 2016, explosion. (Photograph from Google Earth, dated November 2015.)

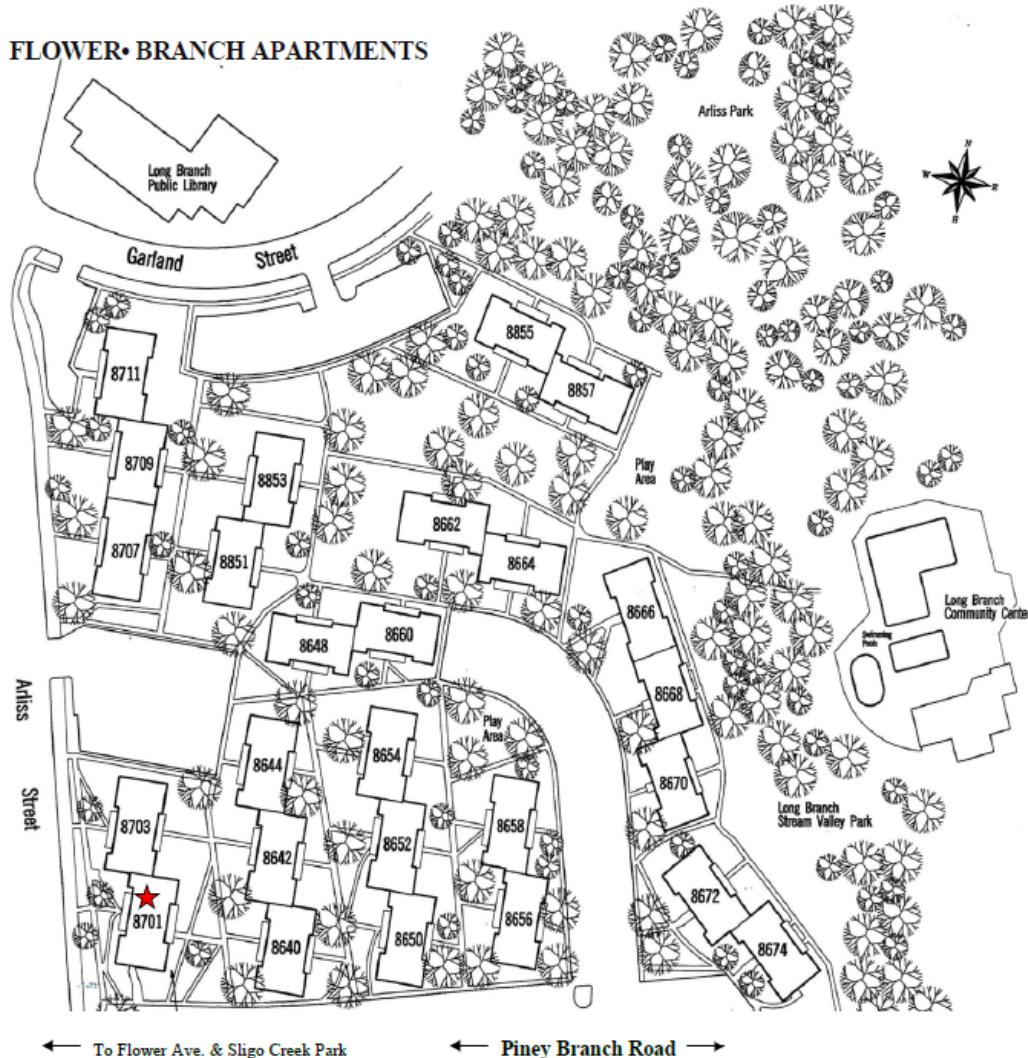
Figure 3. Layout of the Flower Branch apartment complex. Building 8701 is identified by a red star. (Graphic provided by Kay Management.)

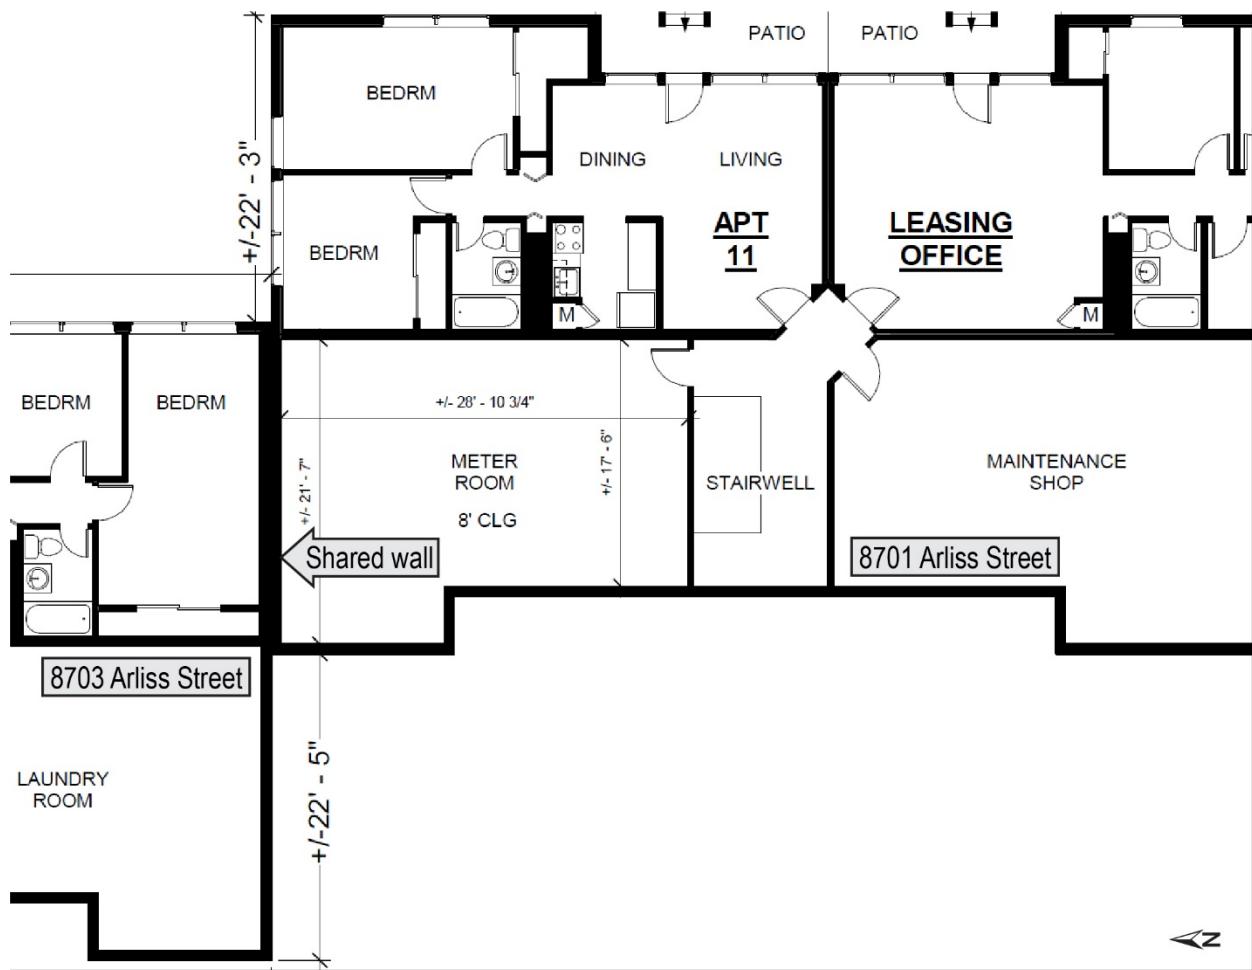
Figure 4. A plan for the basement/terrace floor for 8701 Arliss Street and the shared-wall portion of 8703 Arliss Street. (Graphic provided by Kay Management.)

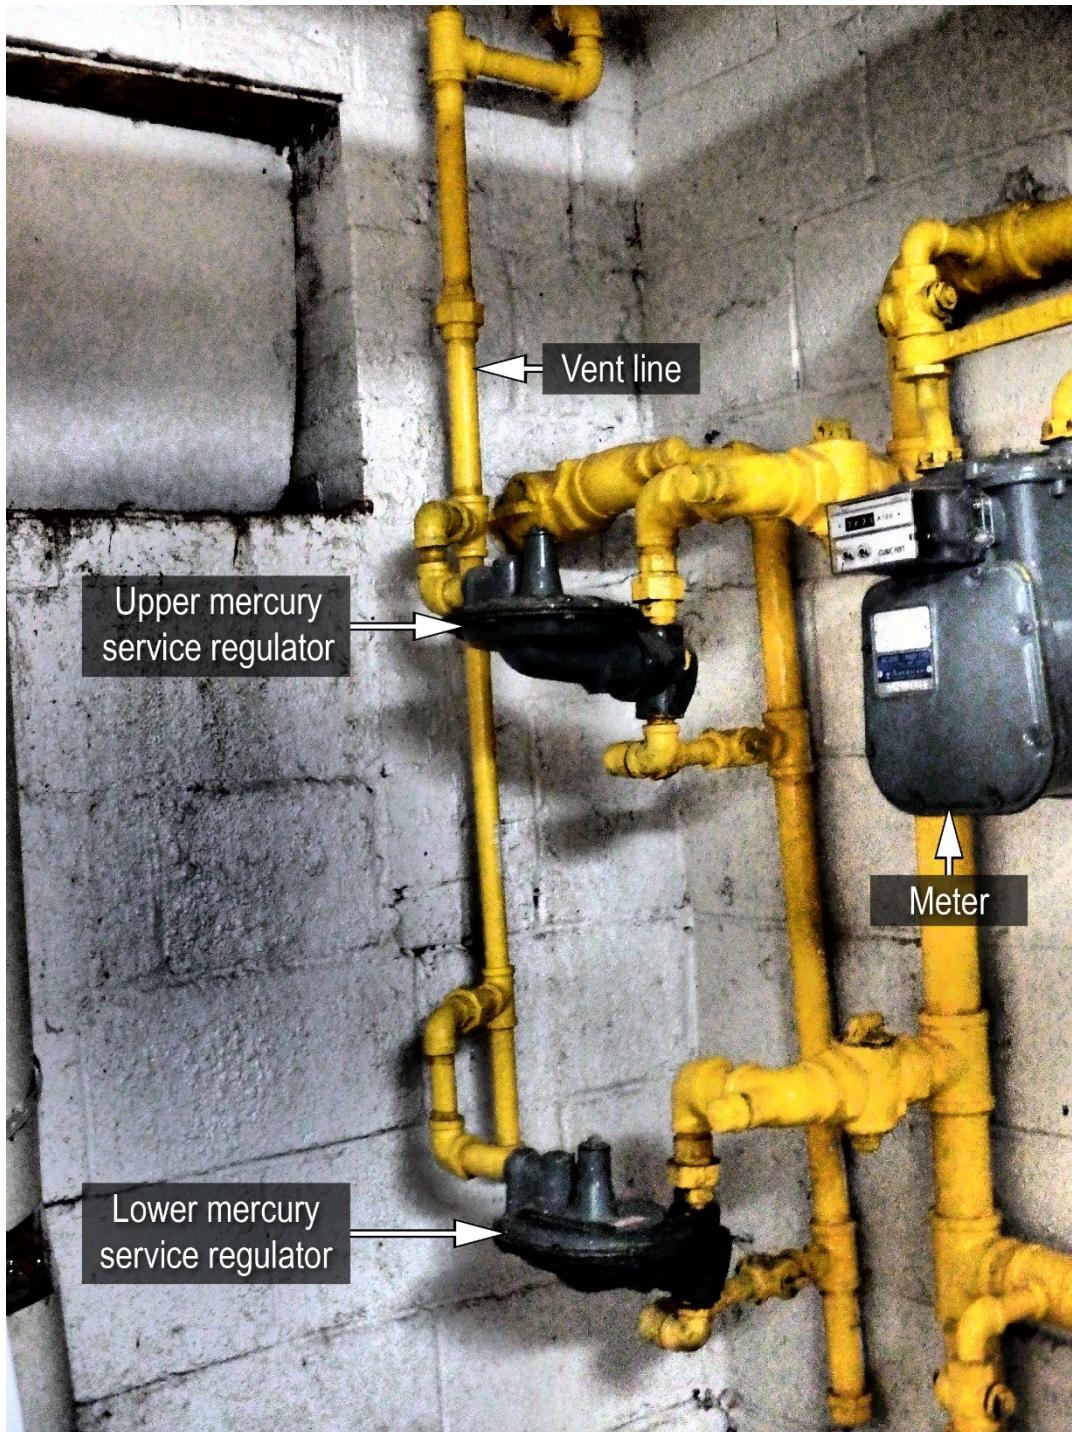
According to WG, the regulators installed in building 8701 were also installed in all 26 buildings of the Flower Branch apartment complex between 1955-1956.²⁵ The two mercury service regulators and their associated piping in building 8701 will be referred to in this report as the “upper” and “lower” service regulators. Based on similar installations in other nearby Flower Branch apartments, it appears the lower regulator was installed about 2 feet above the floor, as seen in figure 7.

Figure 7. Exemplar configuration of a mercury service regulator assembly in a similar Flower Branch apartment building.

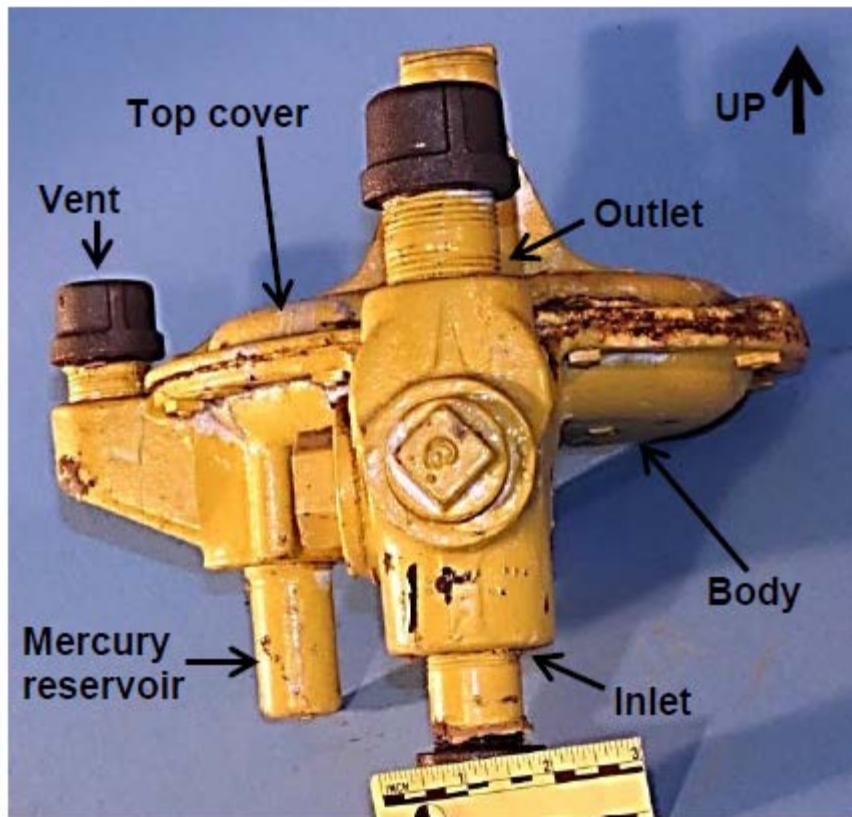
Figure 8. Exemplar mercury service regulator taken from a nearby Flower Branch apartment building.

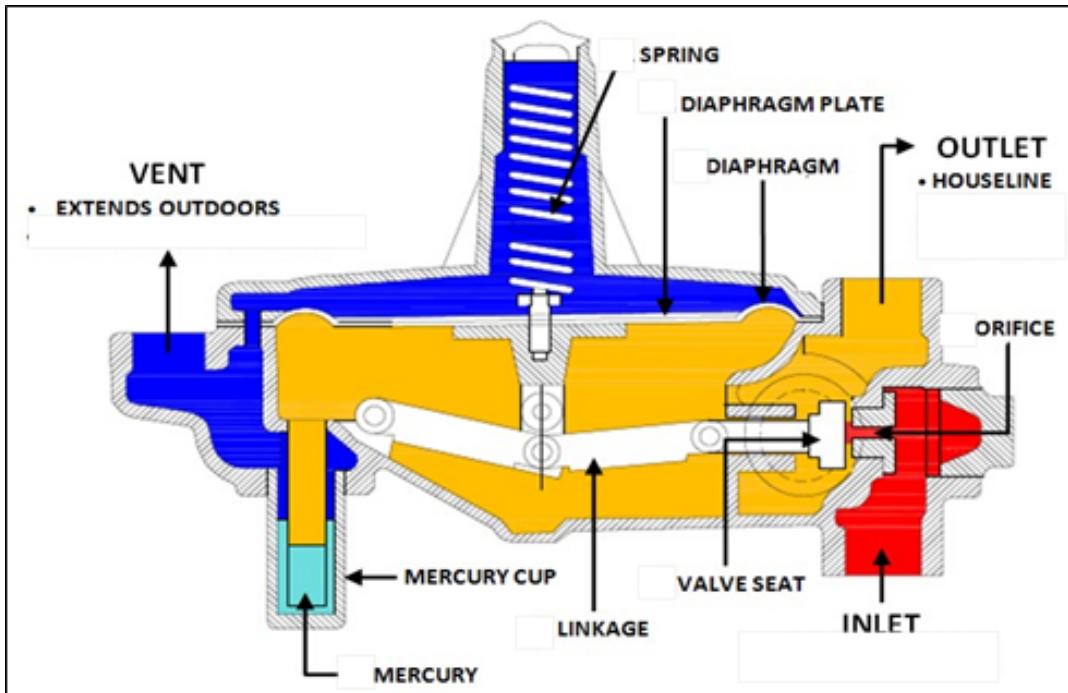
1. Spring used to adjust the natural gas delivery pressure.
2. Leather diaphragm and metal diaphragm plate serve as the pressure-sensing elements and translate pressure into a force to counterbalance the force of the spring.
3. Valve seat (also referred to as a disc) provides a positive shutoff under no-flow conditions.
4. Linkage that transmits the motion of the diaphragm to the valve seat.
5. Orifice is the passageway where pressure is reduced as distribution gas flows.
6. Mercury cup to store a specified amount of mercury for overpressure protection.

Figure 9. Cross sectional image of a mercury service regulator. (Diagram provided by WG.)

In general, the gas regulator assembly operates as shown in figure 9. Under normal operations, gas enters the regulator through the inlet and flows out of the outlet to the gas meter and customer line. The size of the gap between the orifice and valve seat determines the amount of gas that passes through the outlet. The size of the orifice also has a bearing on the outlet pressure, but the size is predetermined prior to installation and remains fixed throughout the service life.

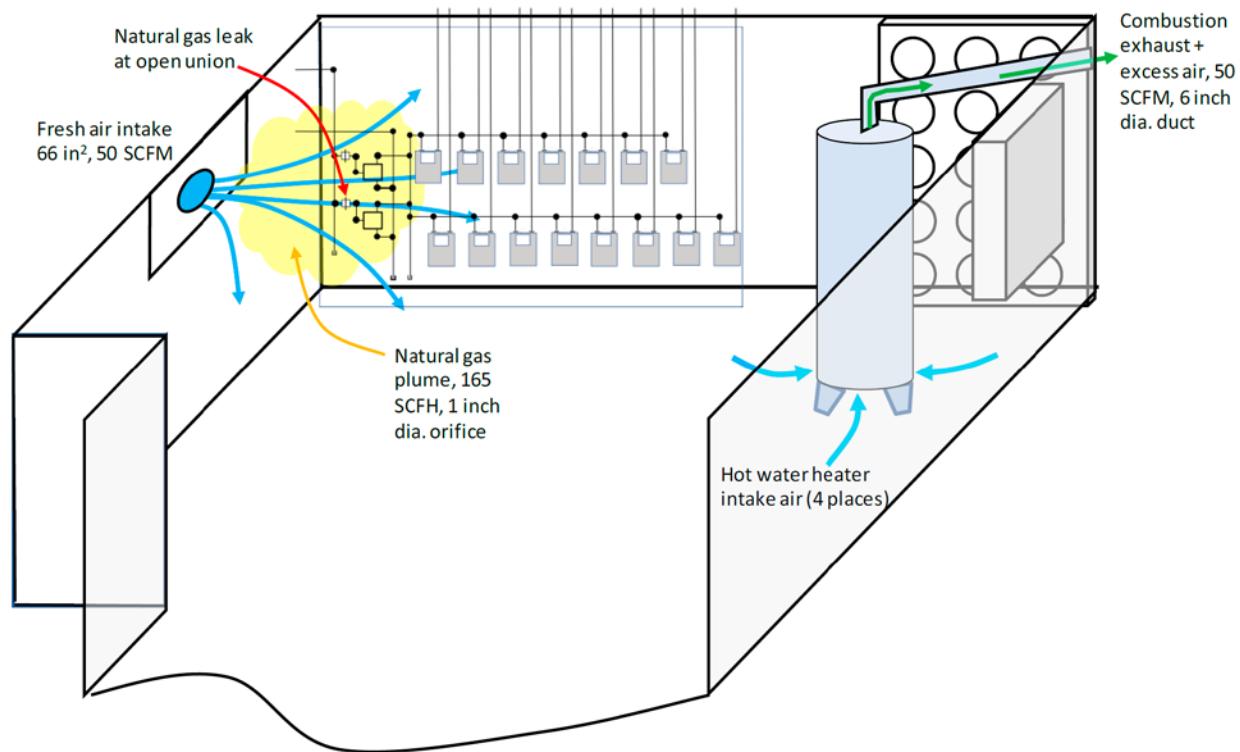
regulator vent leak would reduce to zero. The water heater was assumed to be active 20 minutes of every hour. WG provided gas composition analysis and the concentration for LEL for the gas being delivered to the Flower Branch apartments on the day of the accident. The LEL was reported to be 4.78 percent, which was used in the model. The general configuration of the meter room can be seen in figure 16.

Figure 16. Three-dimensional visualization of the meter room.

According to the time stamp of the alarm records, the last maintenance person locked the meter room at 8:42 p.m., and the explosion occurred at 11:51 p.m. There were no reports of gas odors by residents or maintenance crew at or before 8:42 p.m. The next person to detect a gas odor was a resident of building 8701 who arrived home about 30 minutes before the explosion. Therefore, the natural gas had about 3 hours to accumulate to its explosive range.
