**PUBLIC SERVICE COMMISSION OF THE DISTRICT OF COLUMBIA
1333 H STREET, N.W., 2nd FLOOR, WEST TOWER
WASHINGTON, D.C. 20005**

**FORMAL CASE NO. PEPACR-2014-01, IN THE MATTER OF THE COMMISSION'S
FUEL ADJUSTMENT CLAUSE AUDIT AND REVIEW PROGRAM – ANNUAL
CONSOLIDATED REPORT, Order No. 17816**

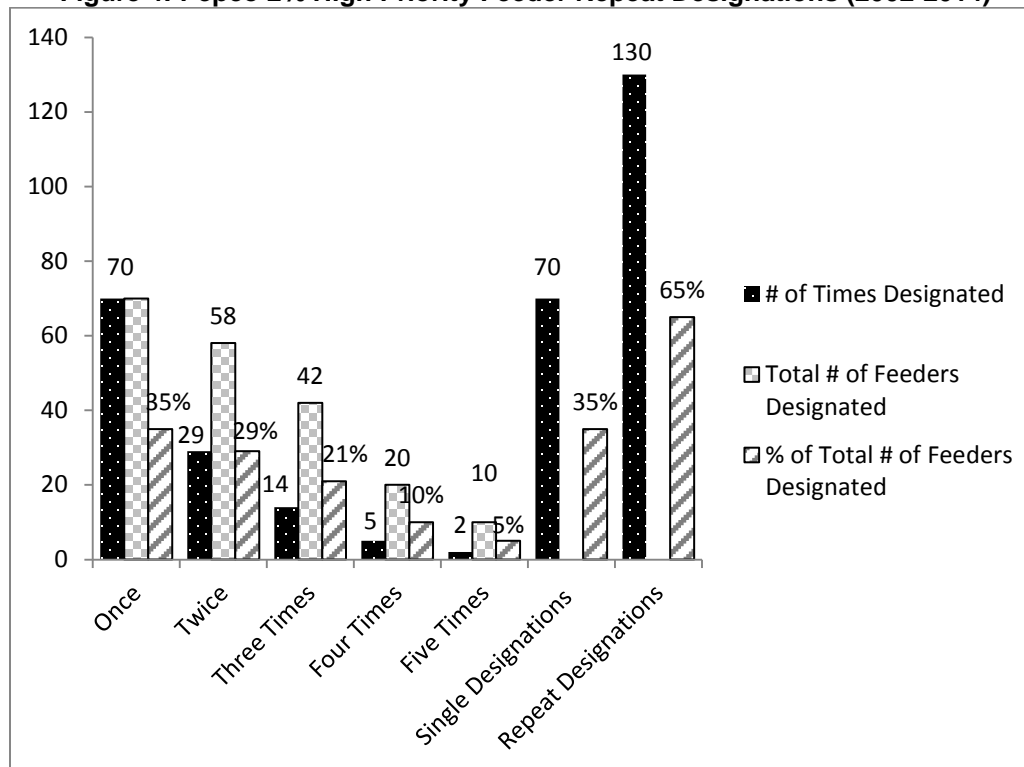
Figure 4: Pepco 2% High Priority Feeder Repeat Designations (2002-2014)

174. Pepco's 2013 and 2014 ACRs reported 2% High Priority Feeders identified in Table R, below and Figure 4 which follows, depict the number of repeat designations among the 200 2% High Priority Feeders designated as such over the life of the program:

Figure 1	Pepco's 5-Year SAIFI (2009-2013)	40
Figure 2	Pepco's 5-Year SAIDI – hrs (2009-2013)	40
Figure 3	Pepco's 5-Year CAIDI - hrs (2009-2013)	40
Figure 4	Pepco 2% High Priority Feeders - Repeat Designations (2002-2014)	71
