2020 CONSOLIDATED REPORT

- **Comprehensive Plan**
 - **Productivity Improvement Plan**
 - **Manhole Event Report**
-
-

POTOMAC ELECTRIC POWER COMPANY

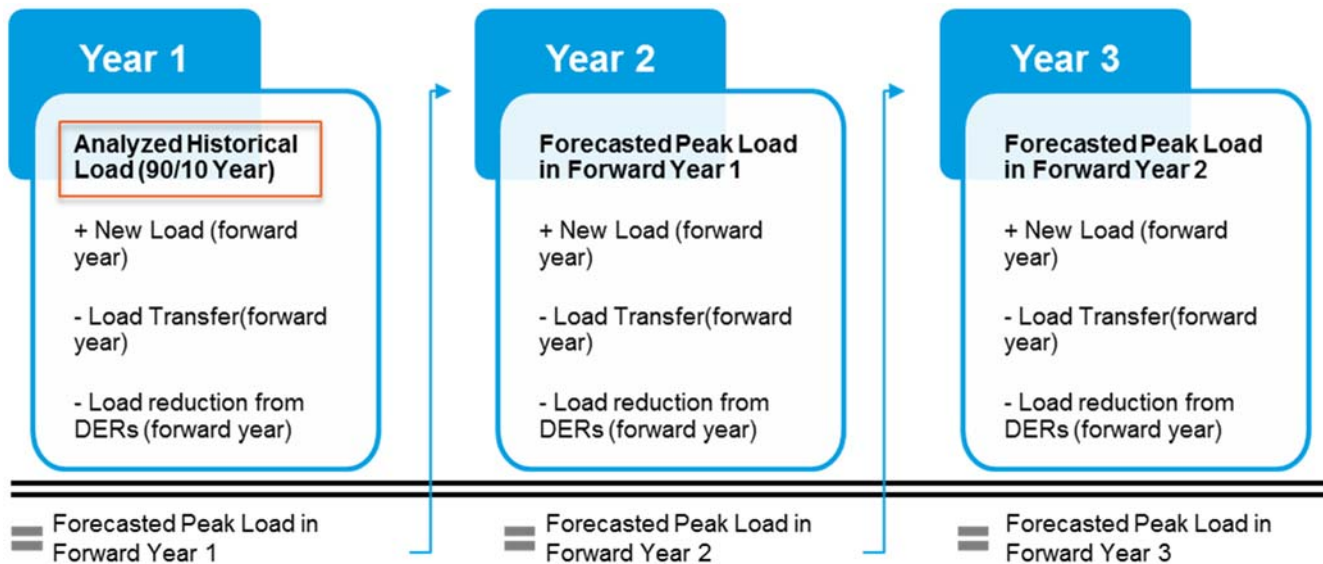
Figure 1.2-B: General Process for Creating Distribution Feeder, Substation Transformer, and Substation Short-Range Forecasts

The peak load forecast is comprised of a short-range forecast for future years 1-3 and a long-range forecast for future years 4-10. This short-term forecast also serves as the basis for the development of the longer term 10-year plan. The former is a detailed, “bottom-up” analysis of historical peak load data, projected new load growth and energy reduction initiatives. The latter is a higher-level and “top-down” trending effort based on the PJM (the regional transmission operator or “RTO” responsible for maintaining the stability of the transmission system) system peak load forecast. The short-range forecast is generally formulated in accordance with the calculation detailed in Figure 1.2-B.⁵

For the purposes of this report, terms are defined as follows:

- Analyzed Historical Peak Load** – This value serves as the base value from which future projections are calculated. This value is most often derived for each distribution system component by taking its actual historical peak load⁶ in the hottest year within the last ten years,⁷ and adding to it the incremental load changes (i.e., new loads, load transfers and load reductions from DERs) that have occurred between that hottest year and the year prior to the current year.⁸
- New Load** – This represents additional new load that is anticipated to come online as a result of new building or development activities. At times and in some areas of Pepco’s service territories,

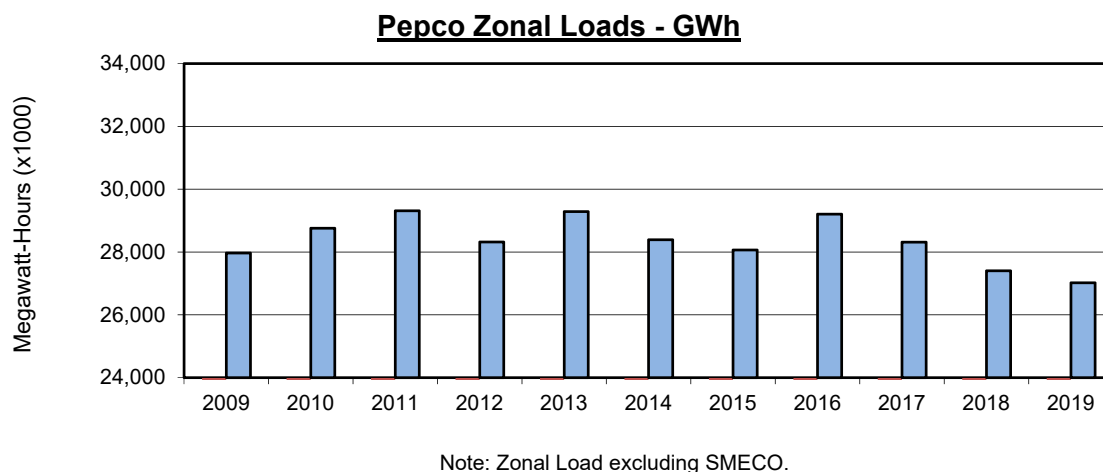
Figure 1.2-C

On a system basis, Pepco’s control area loads over the ten-year period between 2009 and 2019 are provided below in Figure 1.2-C.

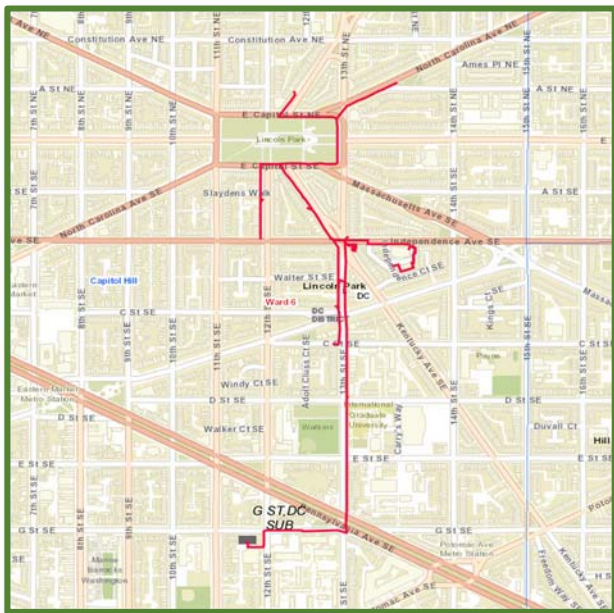
Feeder Map and Location:

<u>County</u>	<u>Substation</u>	<u>Customers Served</u>	<u>Number of Outages</u>	<u>Oct. 2018-Sept. 2019 Reliability Indices</u>			<u>Feeder Miles</u>			<u>Repeated Last 2 Years?</u>
				<u>(In Hours)</u>			<u>OH</u>	<u>UG</u>	<u>Total</u>	
				<u>SAIFI</u>	<u>SAIDI</u>	<u>CAIDI</u>				
DC	G Street (28)	584	12	3.62	484	271	0%	100%	1.90	N

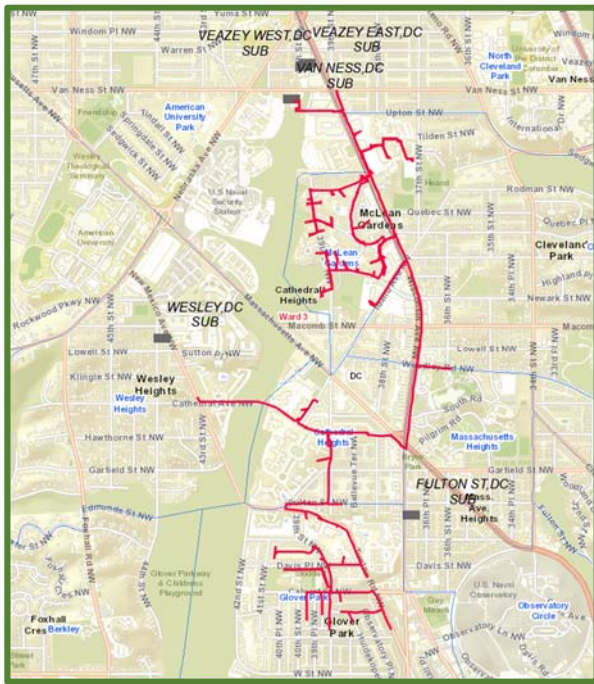
Feeder Map and Location:

<u>County</u>	<u>Substation</u>	<u>Customers Served</u>	<u>Number of Outages</u>	<u>Oct. 2018-Sept. 2019 Reliability Indices</u>			<u>Feeder Miles</u>			<u>Repeated Last 2 Years?</u>
				<u>(In Hours)</u>			<u>OH</u>	<u>UG</u>	<u>Total</u>	
				<u>SAIFI</u>	<u>SAIDI</u>	<u>CAIDI</u>				
DC	Van Ness (129)	1,336	18	1.65	149	769	24%	76%	8.14	N

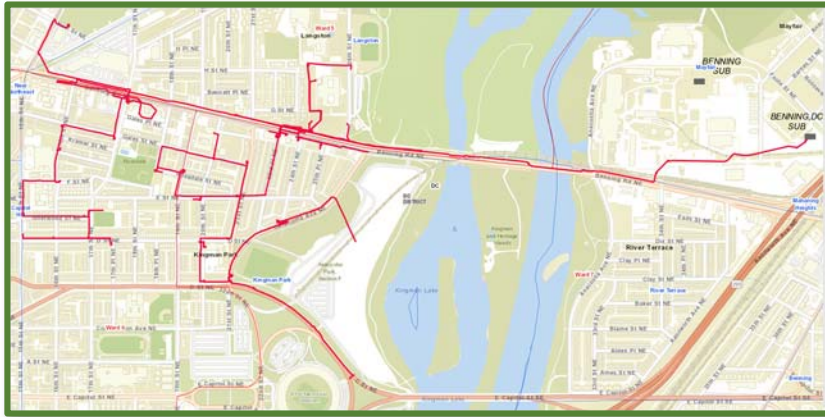
Feeder Map and Location:

County	Substation	Customers Served	Number of Outages	Oct. 2018-Sept. 2019 Reliability Indices			Feeder Miles			Repeated Last 2 Years?
				(In Hours)			OH	UG	Total	
				SAIFI	SAIDI	CAIDI				
DC	Benning (7)	1,798	12	0.73	36	276	7%	93%	7.48	N

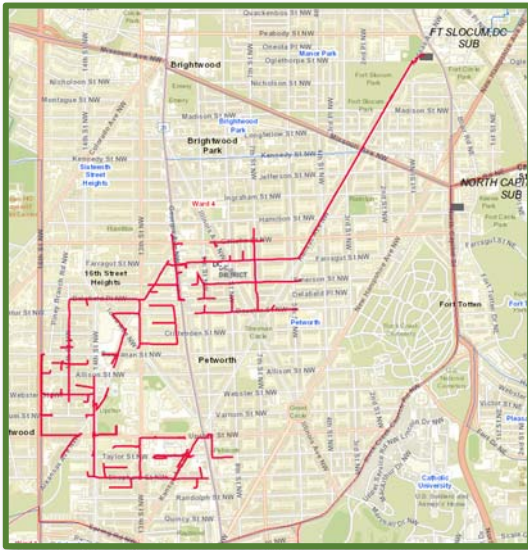
Feeder Map and Location:

County	Substation	Customers Served	Number of Outages	Oct. 2018-Sept. 2019 Reliability Indices			Feeder Miles			Repeated Last 2 Years?
				(In Hours)			OH	UG	Total	
				SAIFI	SAIDI	CAIDI				
DC	Ft. Slocum (190)	2,401	21	2.35	134	417	59%	41%	10.08	N

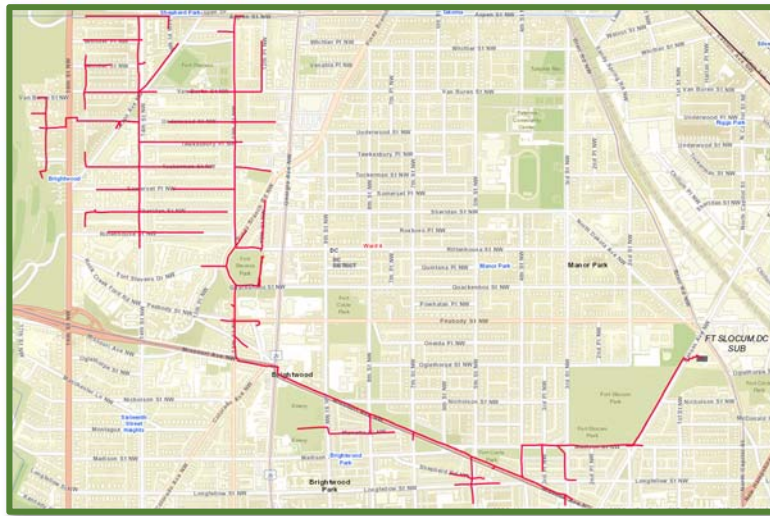
Feeder Map and Location:

<u>County</u>	<u>Substation</u>	<u>Customers Served</u>	<u>Number of Outages</u>	<u>Oct. 2018-Sept. 2019 Reliability Indices</u>			<u>Feeder Miles</u>			<u>Repeated Last 2 Years?</u>
				<u>(In Hours)</u>			<u>OH</u>	<u>UG</u>	<u>Total</u>	
				<u>SAIFI</u>	<u>SAIDI</u>	<u>CAIDI</u>				
DC	Ft. Slocum (190)	2,227	19	2.32	59	499	93%	7%	7.47	Y

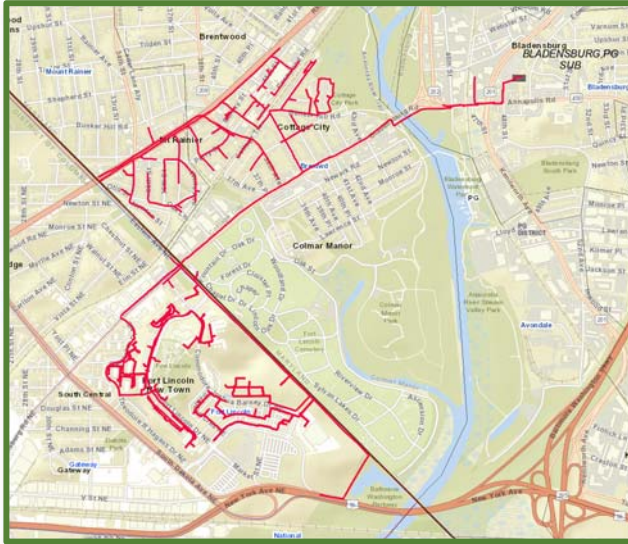
Feeder Map and Location:

<u>County</u>	<u>Substation</u>	<u>Customers Served</u>	<u>Number of Outages</u>	<u>Oct. 2018-Sept. 2019 Reliability Indices</u>			<u>Feeder Miles</u>			<u>Repeated Last 2 Years?</u>
				<u>(In Hours)</u>			<u>OH</u>	<u>UG</u>	<u>Total</u>	
				<u>SAIFI</u>	<u>SAIDI</u>	<u>CAIDI</u>				
DC	Bladensburg (175)	2,510	23	3.20	429	922	39%	61%	21.68	Y

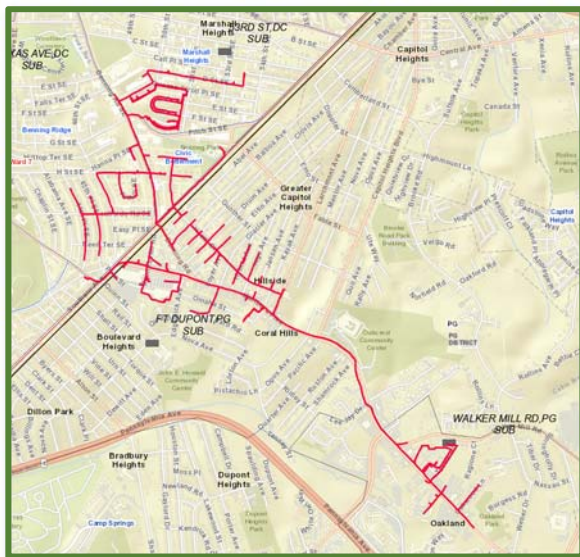
Feeder Map and Location:

<u>County</u>	<u>Substation</u>	<u>Customers Served</u>	<u>Number of Outages</u>	<u>Oct. 2018-Sept. 2019 Reliability Indices</u>			<u>Feeder Miles</u>			<u>Repeated Last 2 Years?</u>
				<u>(In Hours)</u>			<u>OH</u>	<u>UG</u>	<u>Total</u>	
				<u>SAIFI</u>	<u>SAIDI</u>	<u>CAIDI</u>				
DC	Walker Mill (15)	2,027	22	2.79	293	625	68%	32%	11.02	N

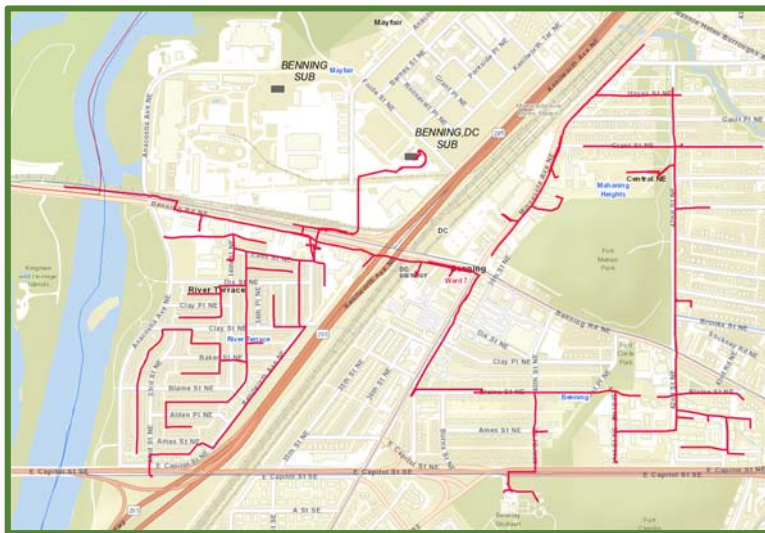
Feeder Map and Location:

County	Substation	Customers Served	Number of Outages	Oct. 2018-Sept. 2019 Reliability Indices			Feeder Miles			Repeated Last 2 Years?
				(In Hours)			OH	UG	Total	
				SAIFI	SAIDI	CAIDI				
DC	Benning (7)	2,207	17	2.06	93	573	79%	21%	8.15	N

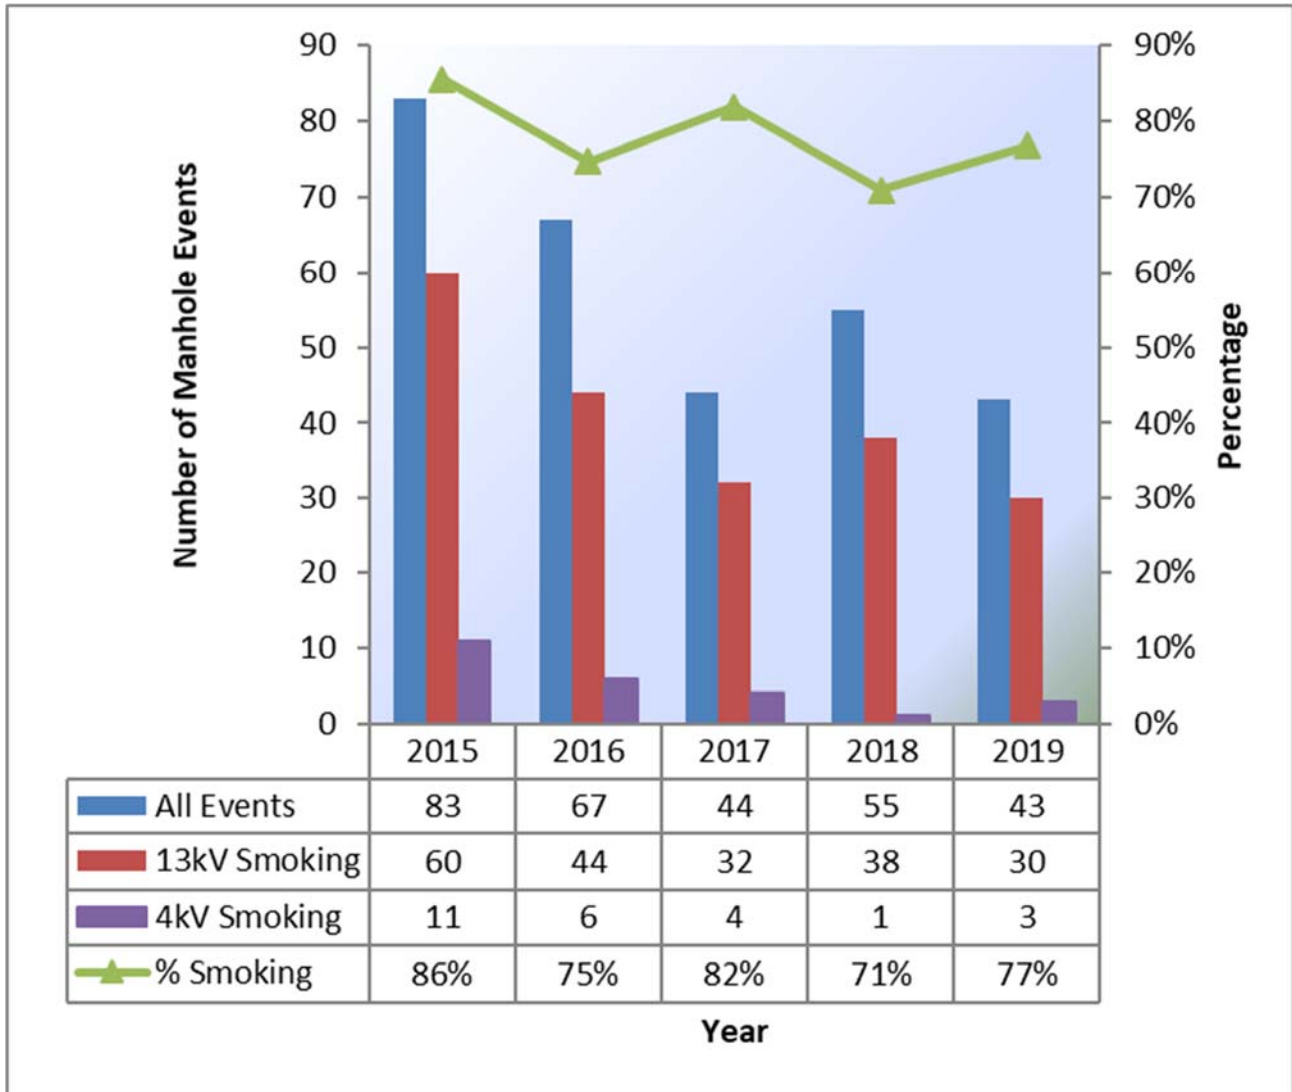
Of these three types, from 2015– 2019 smoking manhole events account for the majority of all manhole events experienced in the District. See Figure 3.1.

Figure 3.1: Manhole Events - Smoking (2015-2019)

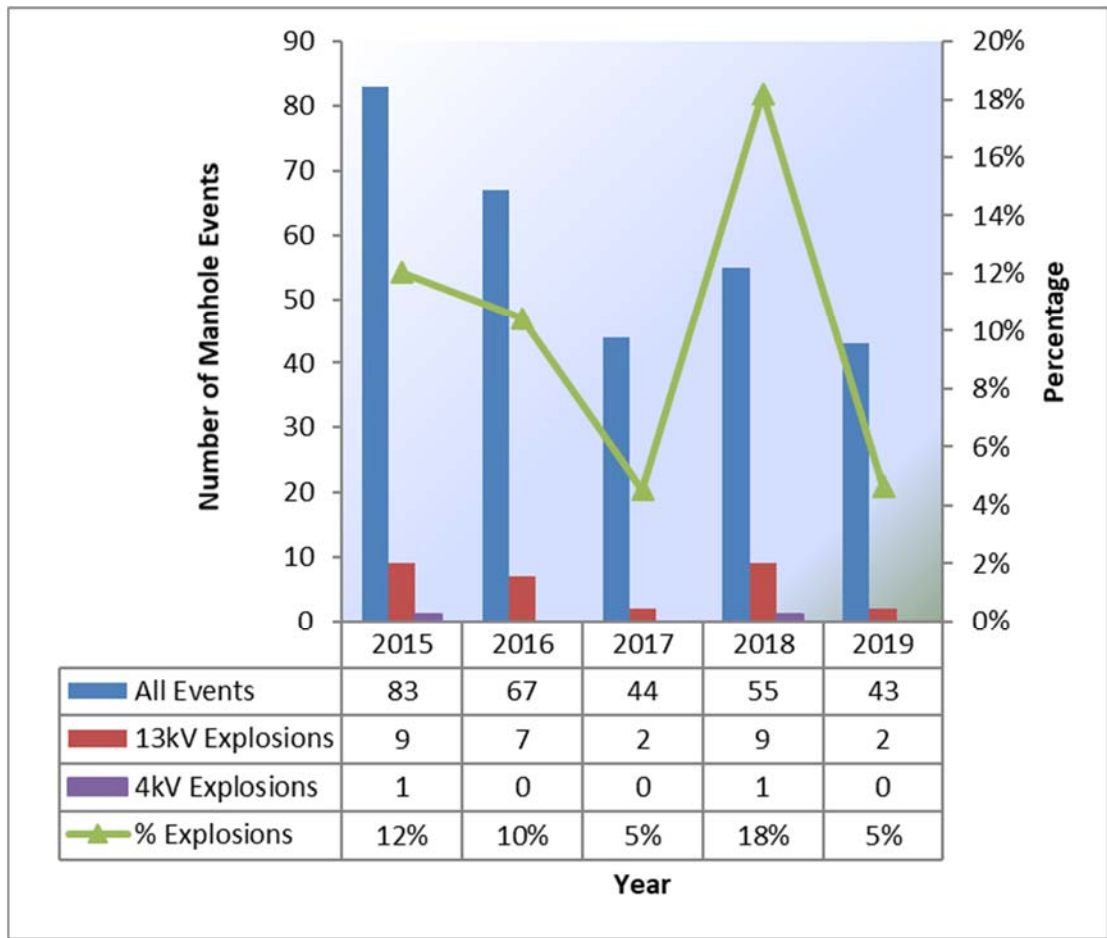
Figures 3.2 and 3.3 breakdown the percentage of manhole fires and manhole explosions as compared to the total number of events. As reflected below, explosions and fires occur less frequently than smoking manholes.

Figure 3.2: Manhole Events - Explosions (2015-2019)

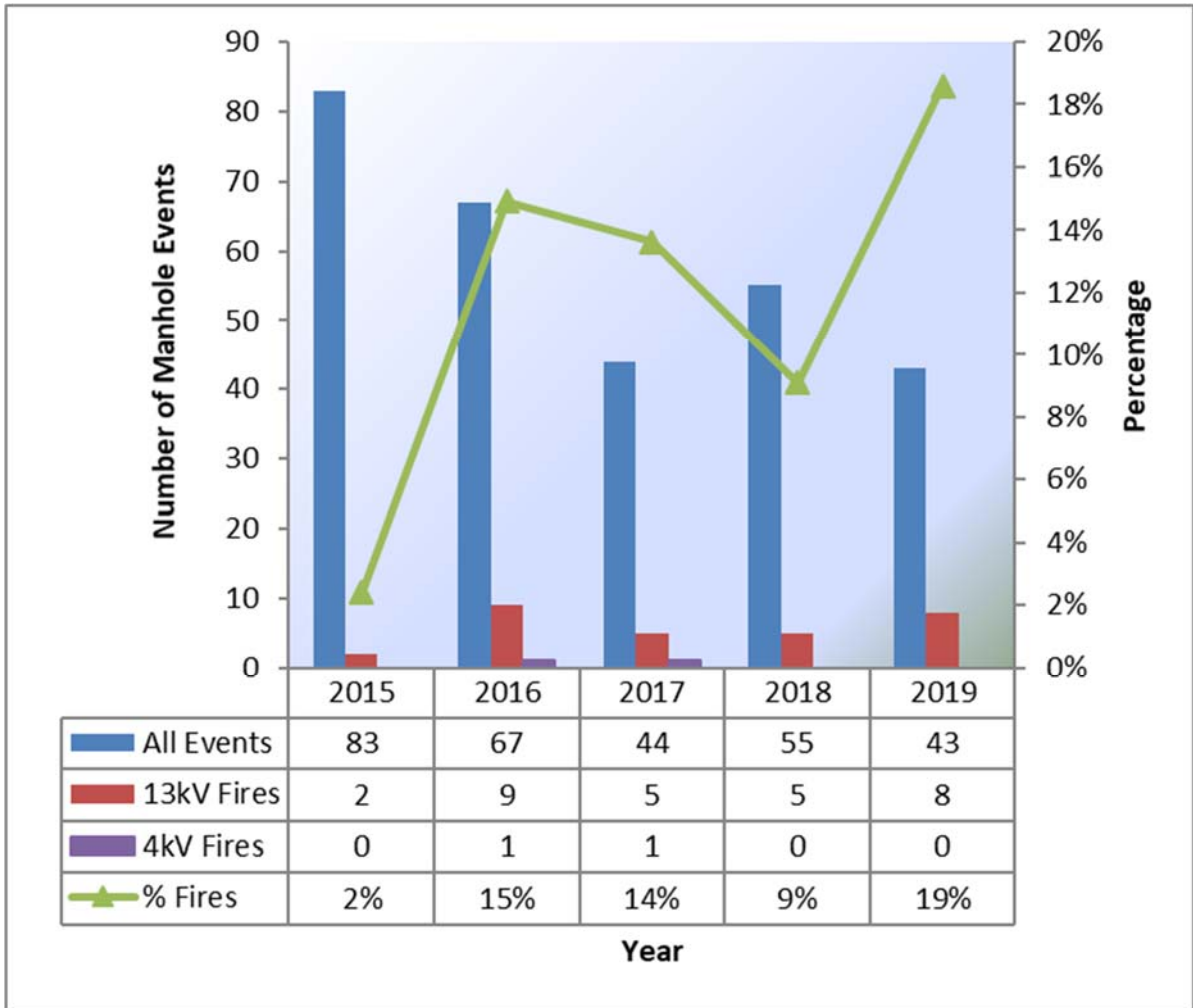
Figure 3.3: Manhole Events - Fires (2015-2019)

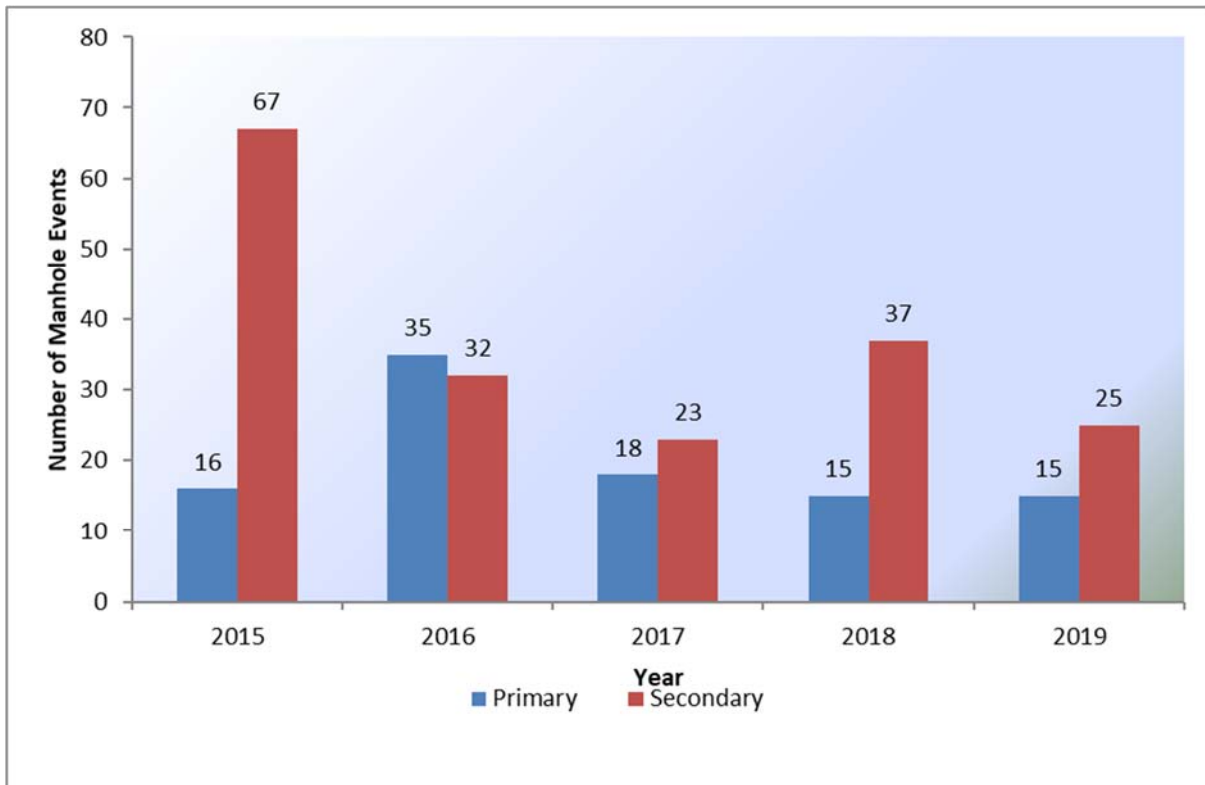
Since 2015, on average the majority of the manhole events experienced in the District have occurred on Pepco’s secondary equipment. See Figure 3.4.

Figure 3.4: Manhole Events by Type of Equipment (2015-2019)

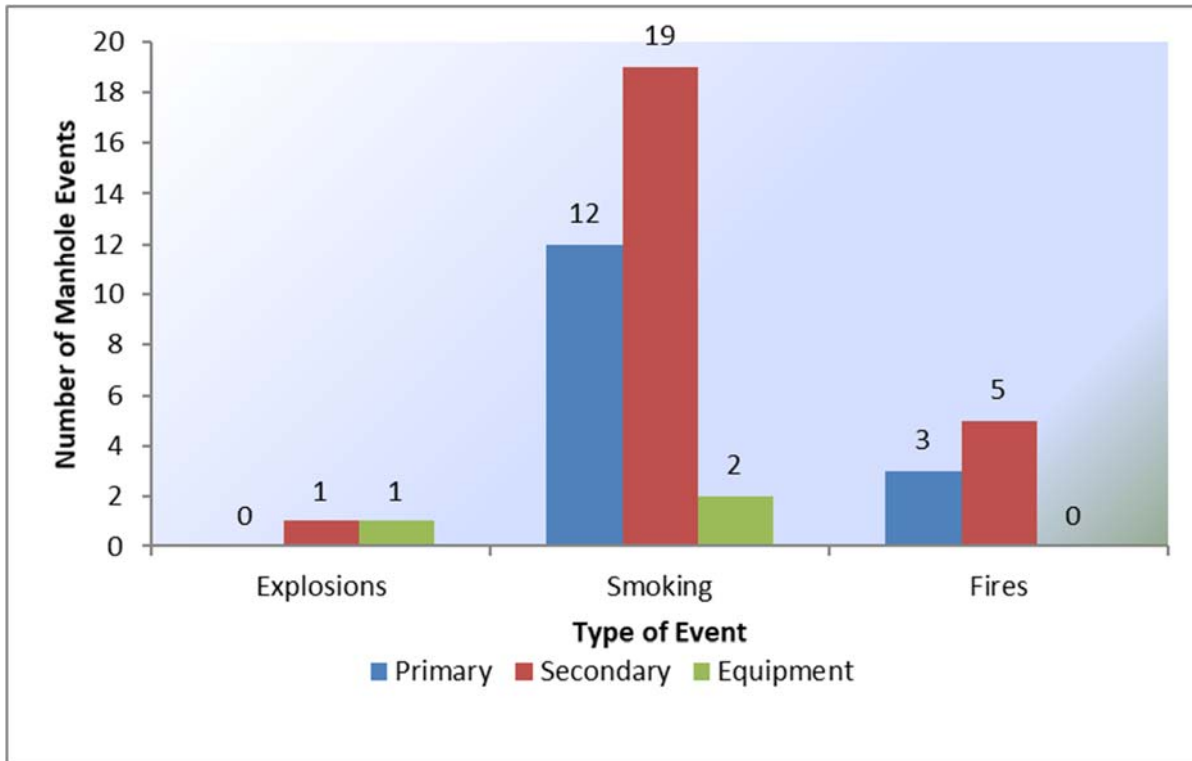
In 2019, manhole explosions occurred slightly more on the secondary systems. Smoking manholes occurred more on the secondary system, and manhole fires occurred slightly more on the primary system. Figure 3.5 depicts this breakdown. See Figure 3.5.

Figure 3.5: Manhole Events by Type and Equipment (2019)

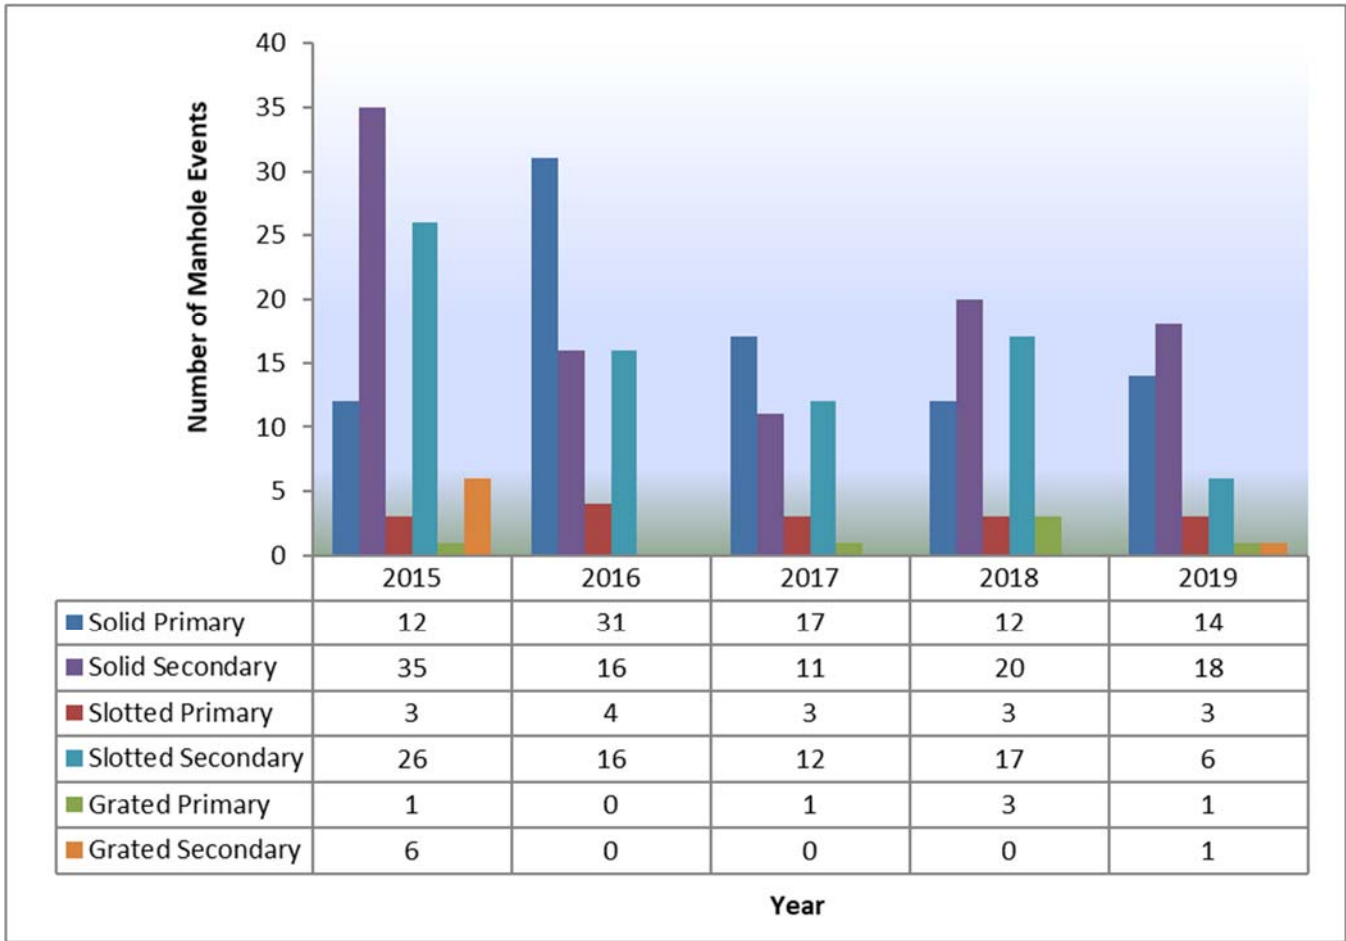
Slotted manhole covers are designed to minimize the frequency and impact of manhole events by allowing gas and smoke to vent from manholes in the event of an underground failure. This provides an early warning and prevents build-up of gases to potentially explosive proportions; thereby allowing energy to disperse more easily should an event occur. The tradeoff when installing slotted covers is that they allow more water and street run-off contaminants to enter into the manhole than solid covers. More analysis on the effects of slotted covers and manhole events is presented in the slotted MH cover section of this report. See Figure 3-6 and Figure 3-7 for a breakdown of manhole event by event type, voltage class, and cover type.

Figure 3.6: Manhole Events by Type, Equipment, and Manhole Cover (2015-2019)

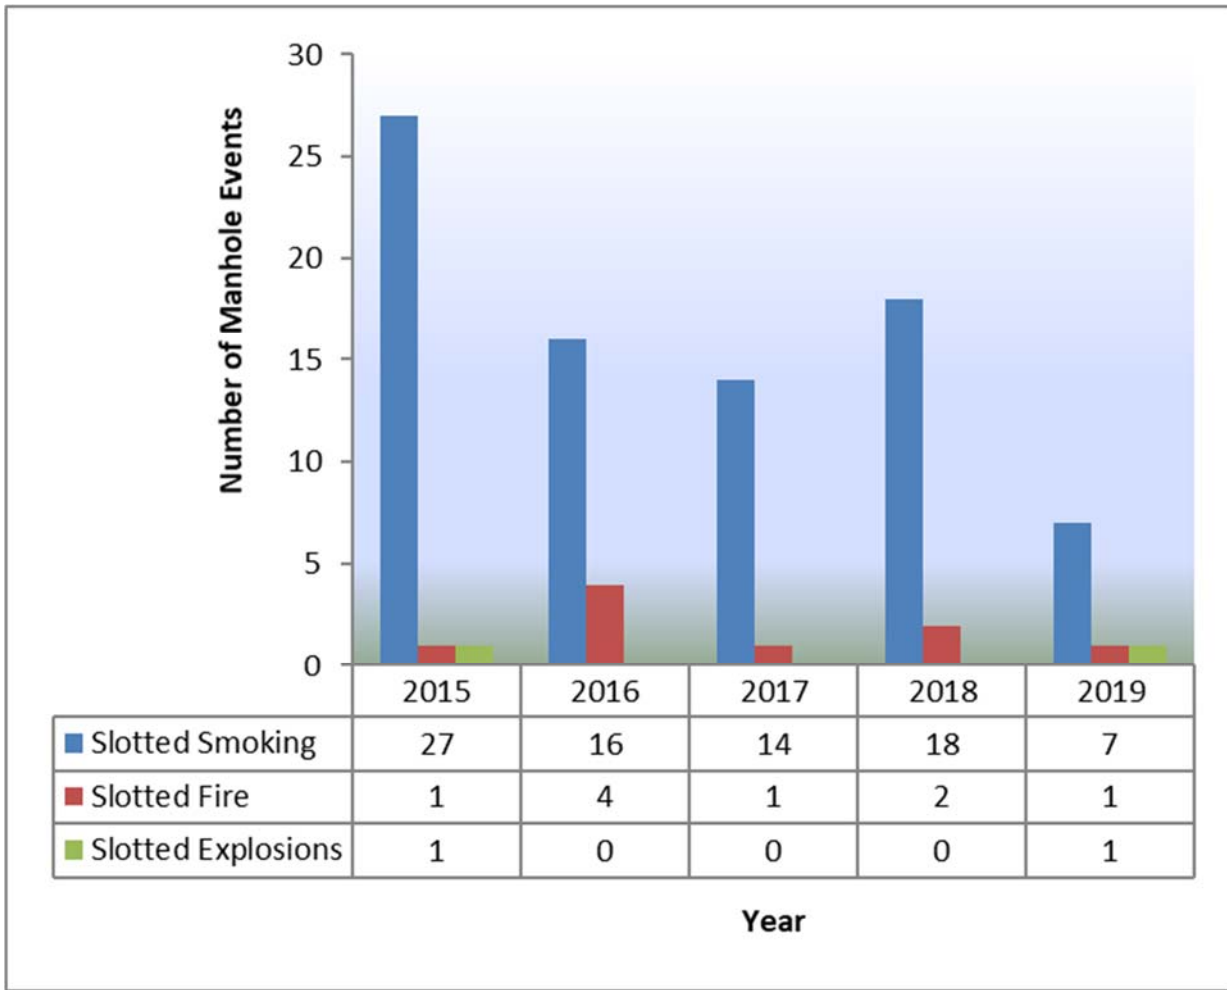
Figure 3.7: Slotted Manhole Events by Type (2015-2019)

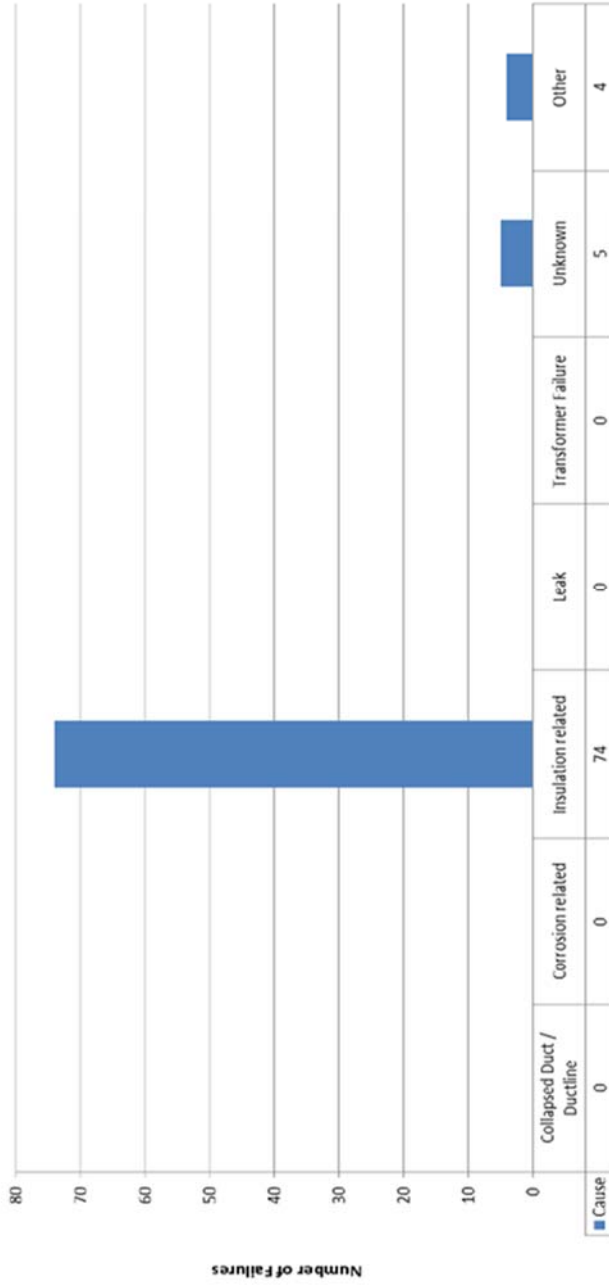
By design, primary cable is more insulated than secondary cable. Whereas primary cable and its accessories are designed to their voltage rating and are shielded, secondary cable and its accessories are not shielded. As a result of less physical protection, secondary cable and its accessories are more likely to fail due to a breach in the insulation. Since 2014, the leading cause of manhole reportable events in the District is insulation-related, such as insulation deterioration. See Figures 3.8 through 3.12.

Figure 3.8: Selected Failure Causes (2015)

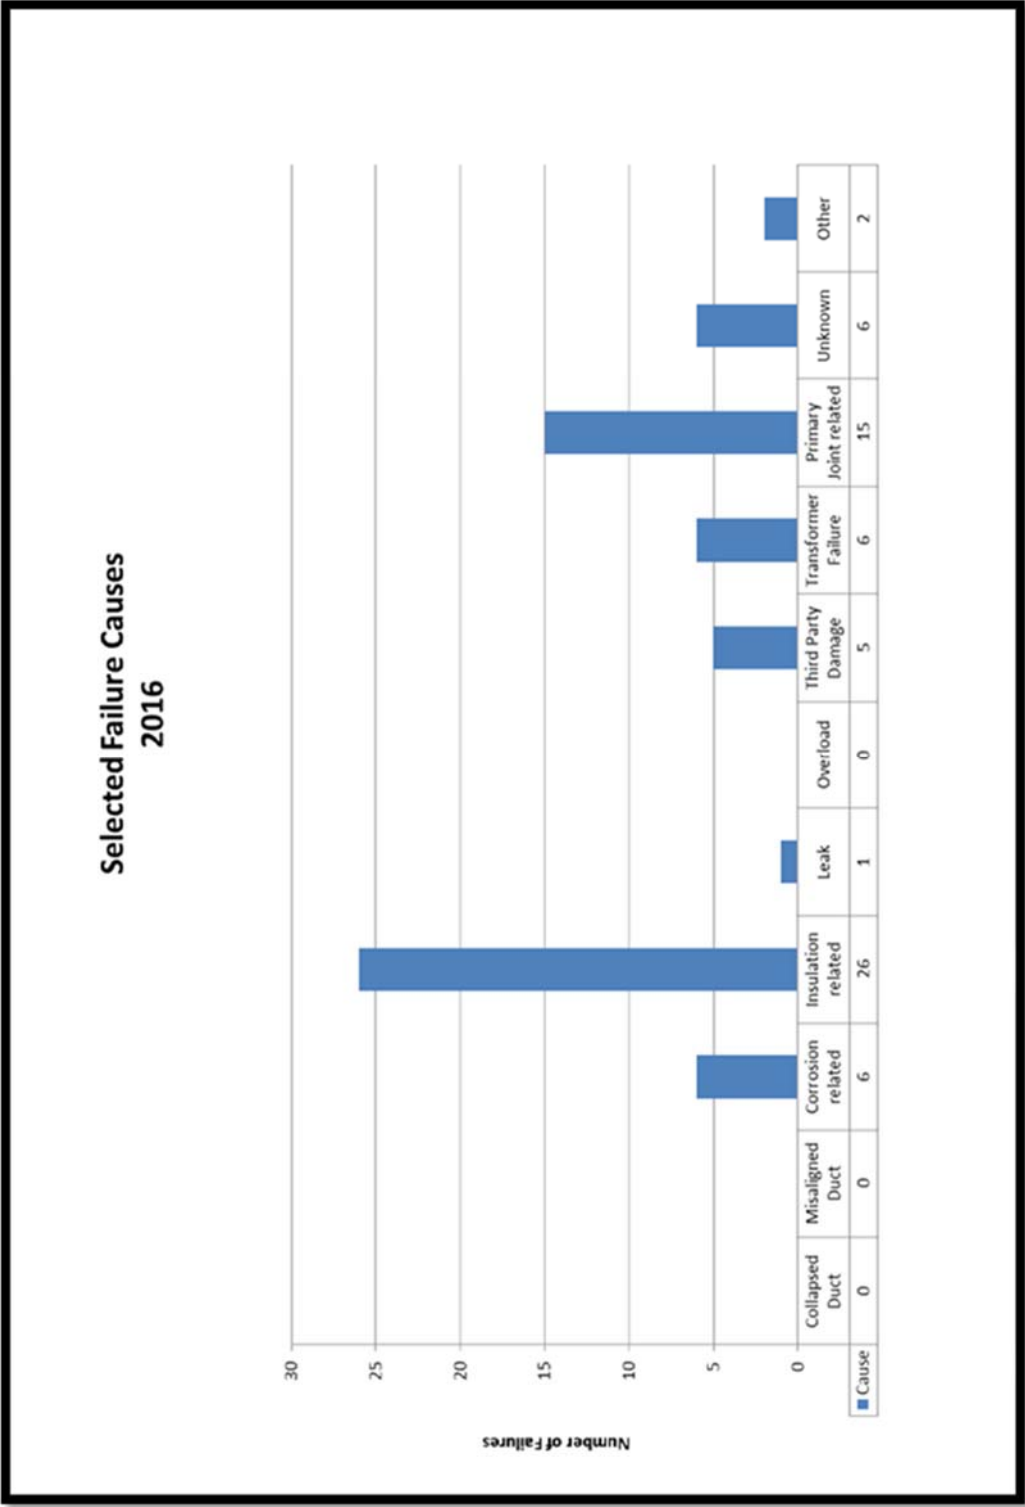
Figure 3.9: Selected Failure Causes (2016)

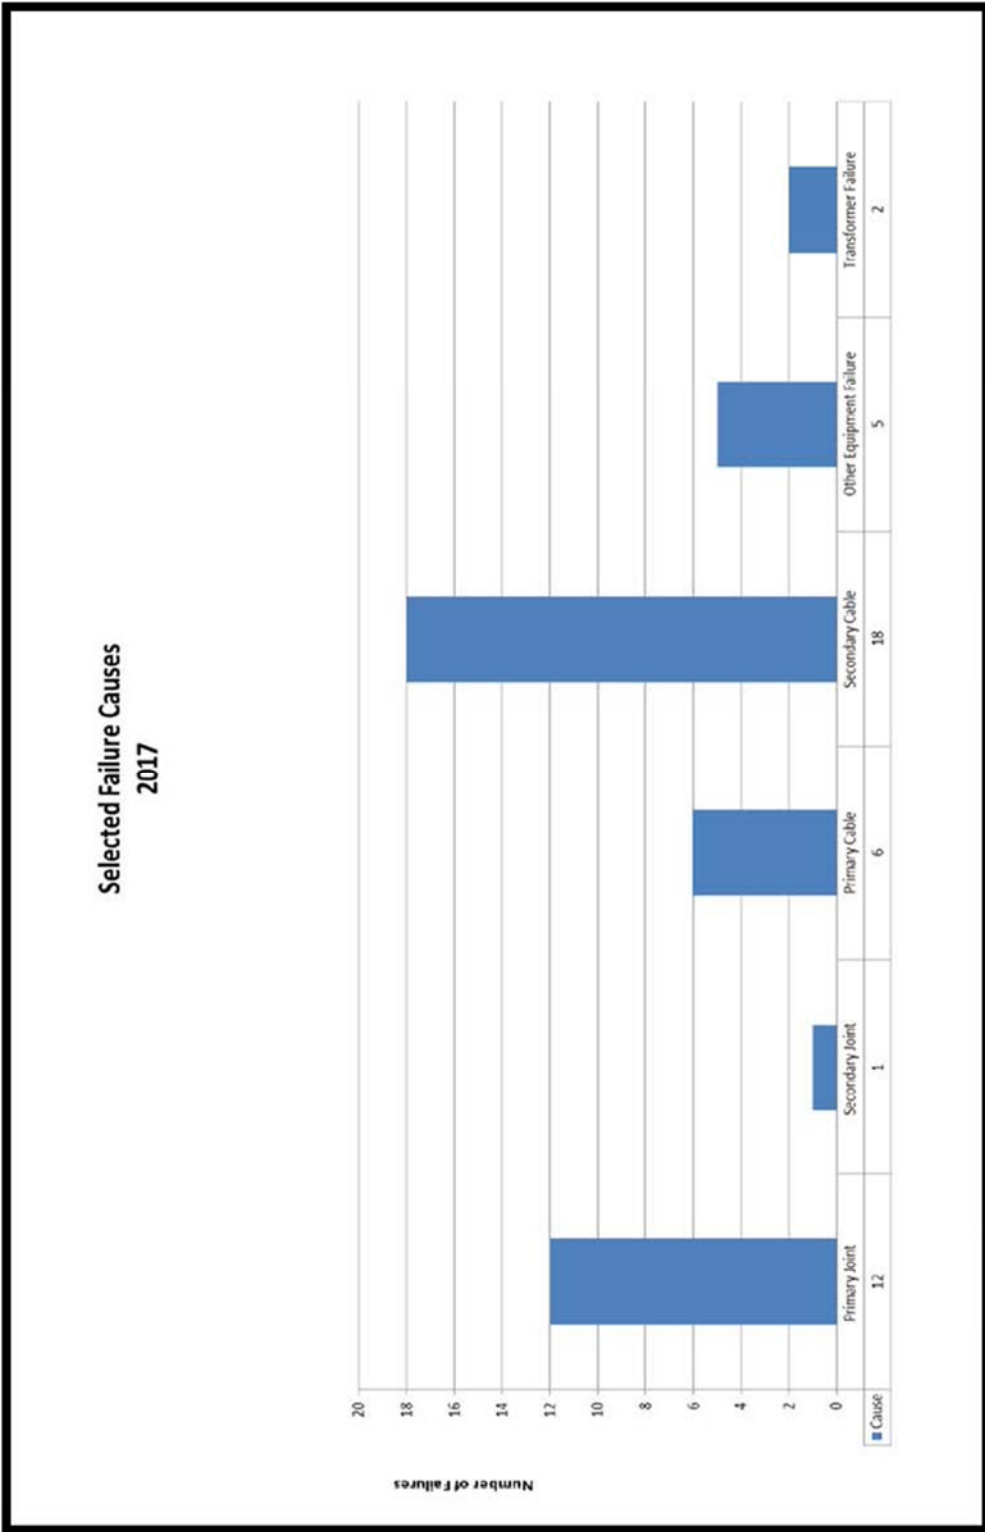
Figure 3.10: Selected Failure Causes (2017)

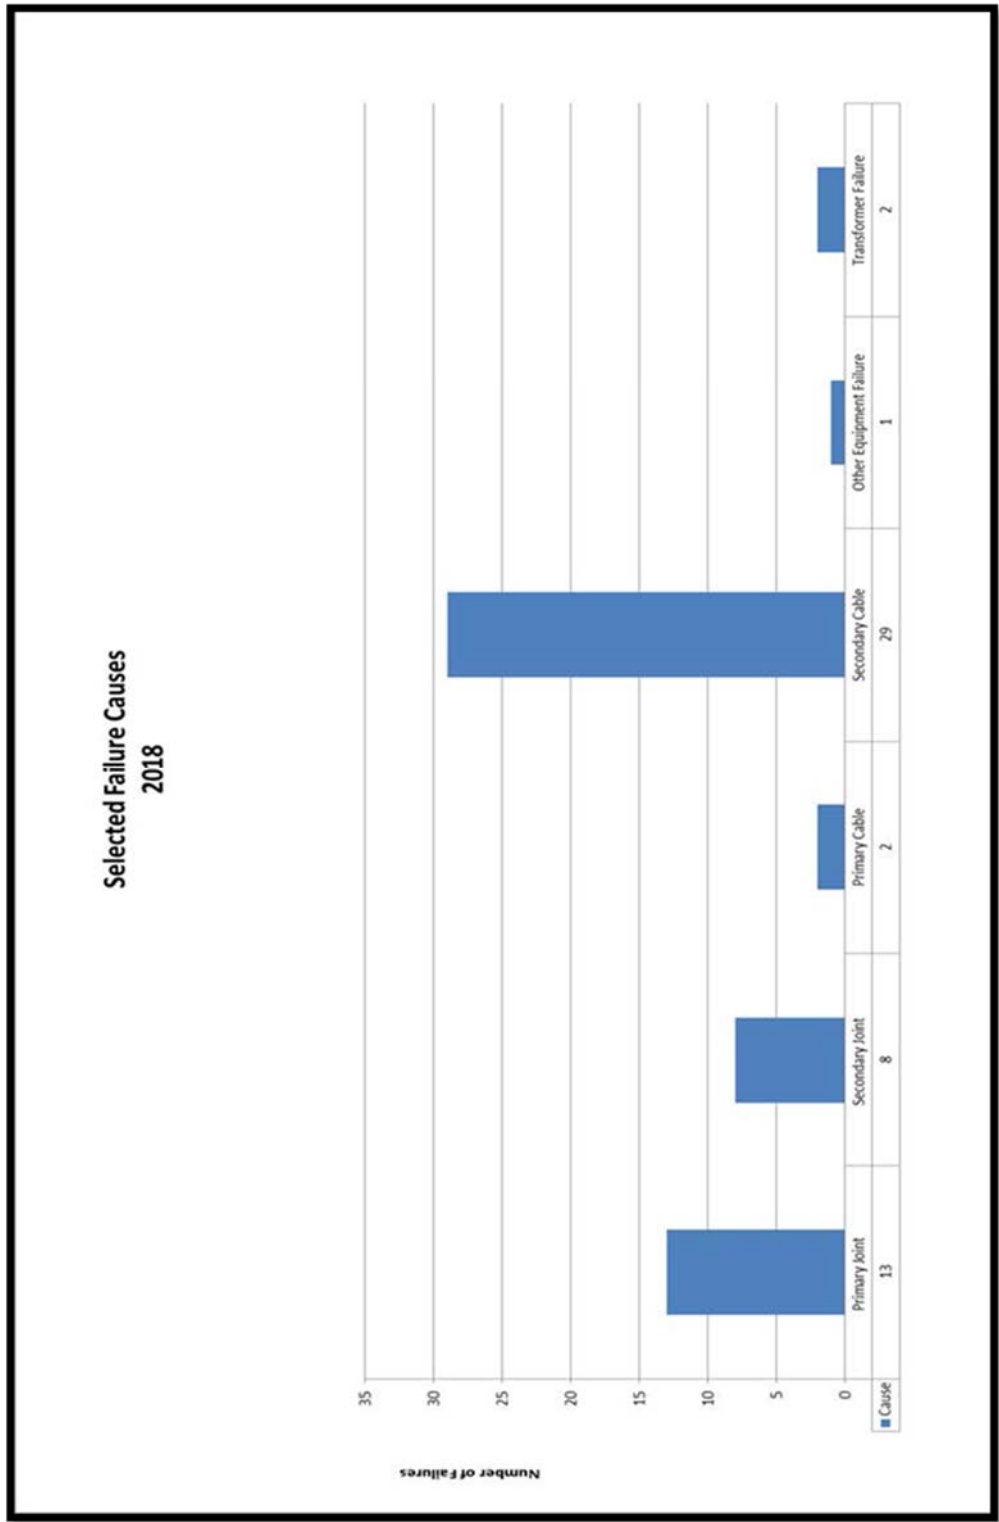
Figure 3.11 Selected Failure Causes (2018)

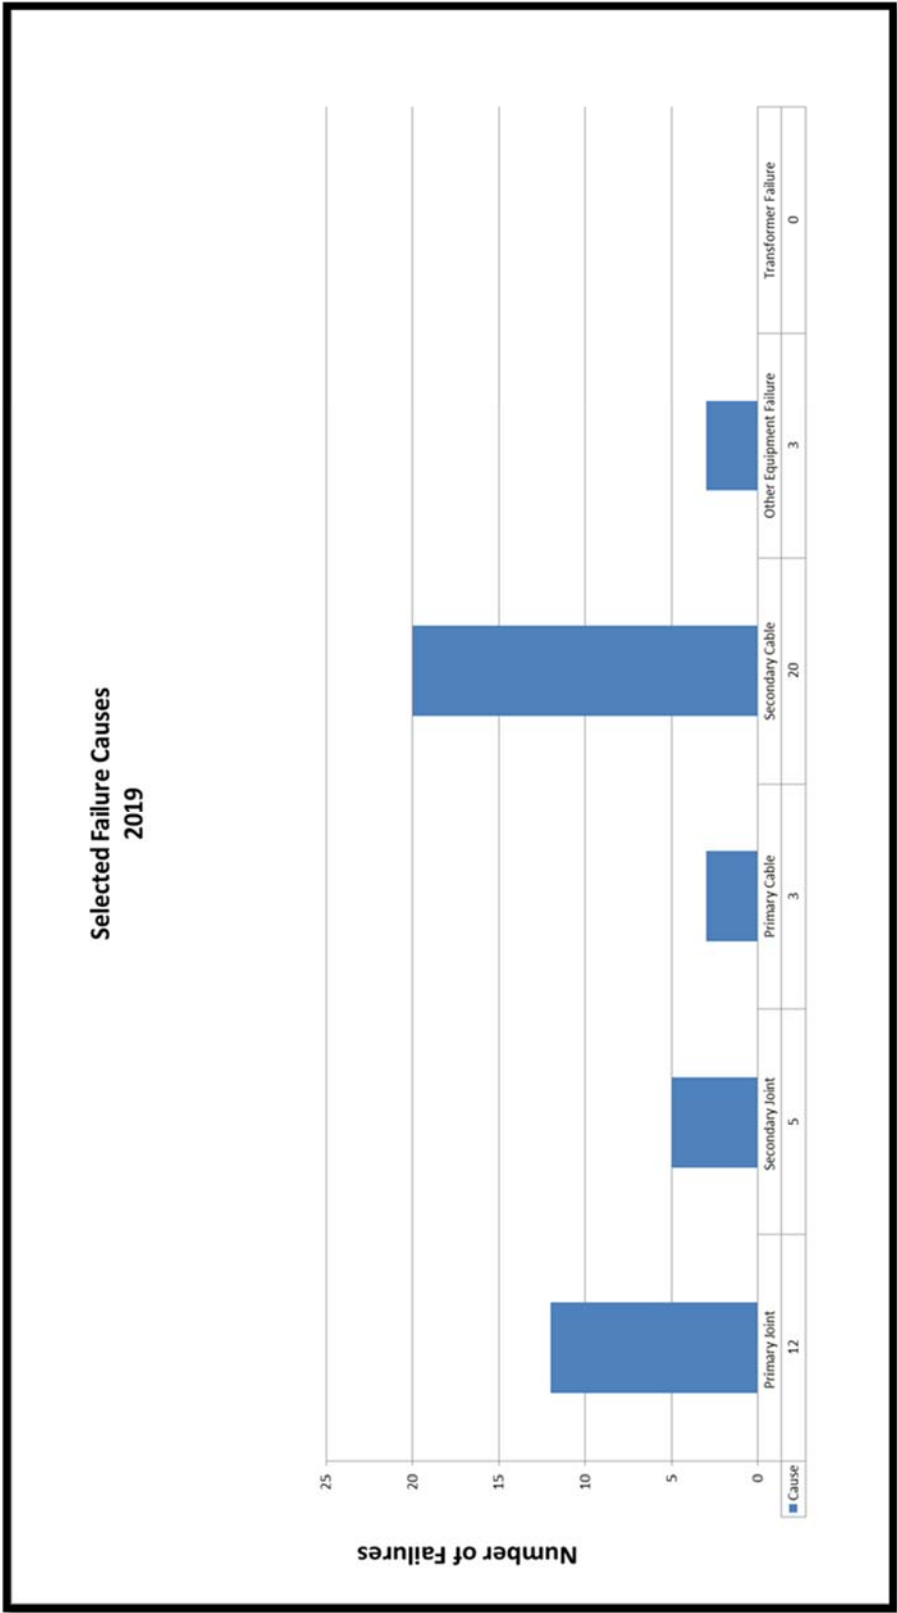
Figure 3.12 Selected Failure Causes (2019)

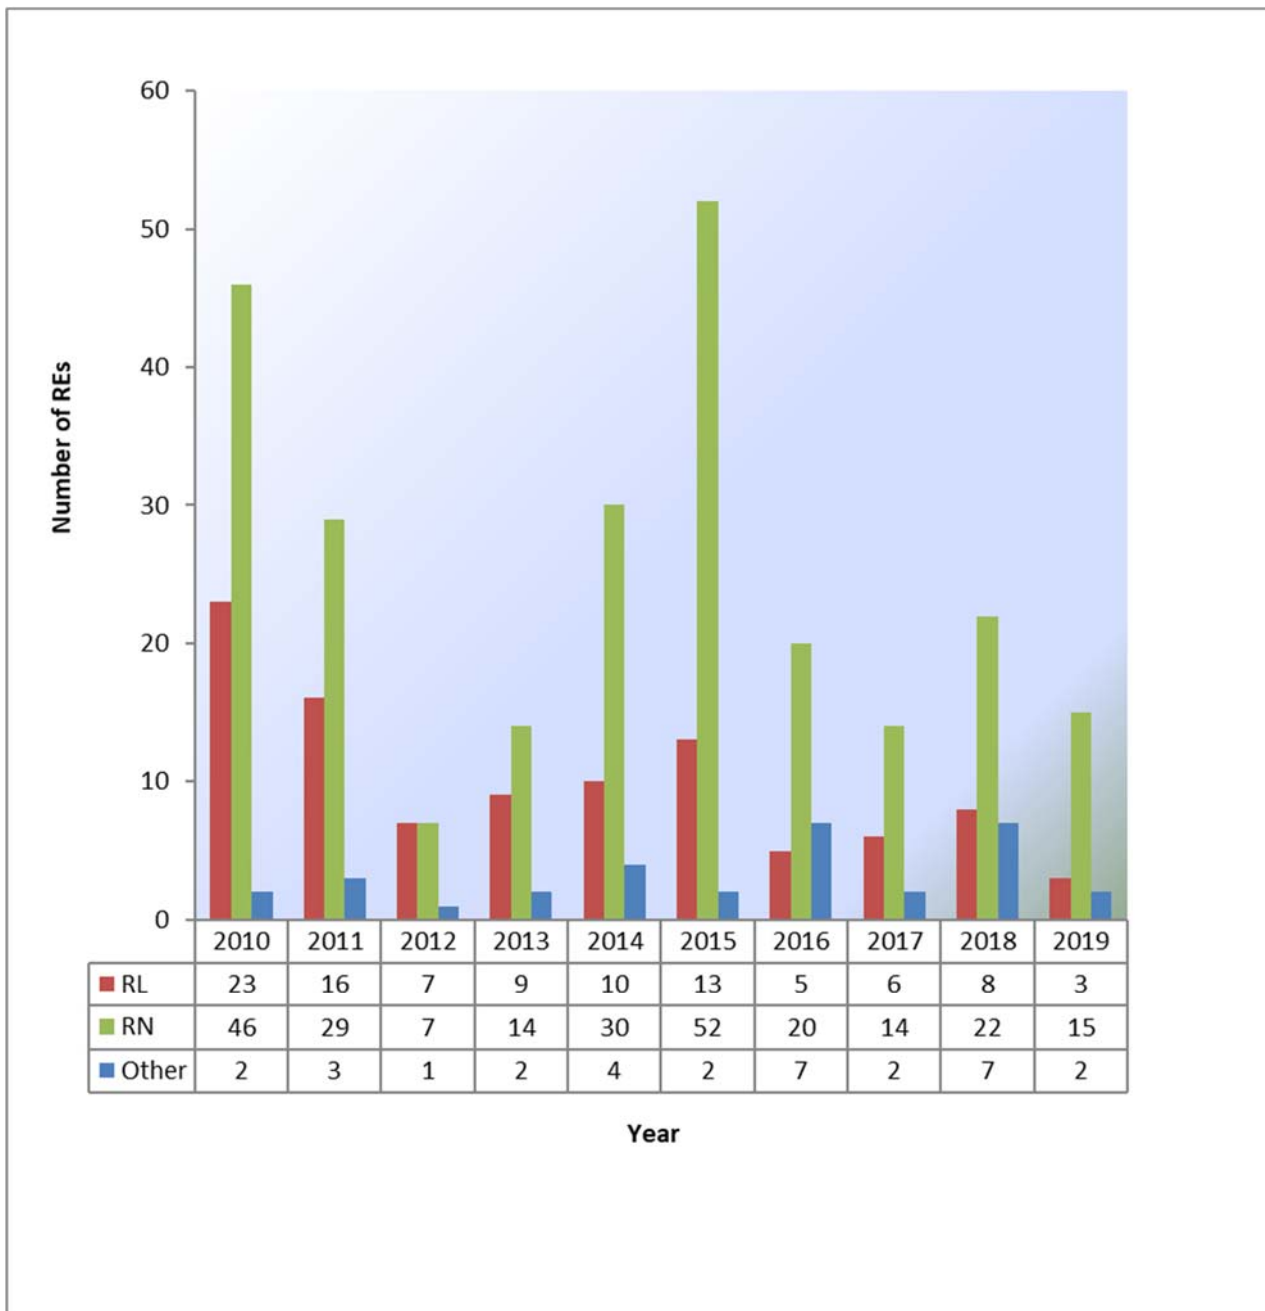
The type of insulation related to cable and joint failures resulting in a reportable event for secondary equipment does not provide a discernible trend in reportable events caused by Rubber Lead (RL), Rubber Neoprene (RN), or other insulation types (Figure 3.13). RL secondary cable is an outdated technology and has not been installed on the system for more than twenty years. It is not possible to trend future reportable events associated with this cable type.

Figure 3.13: Insulation Type of Secondary REs (2010-2019)
