2020 CONSOLIDATED REPORT

- **Comprehensive Plan**
 - **Productivity Improvement Plan**
 - **Manhole Event Report**
-
-

POTOMAC ELECTRIC POWER COMPANY

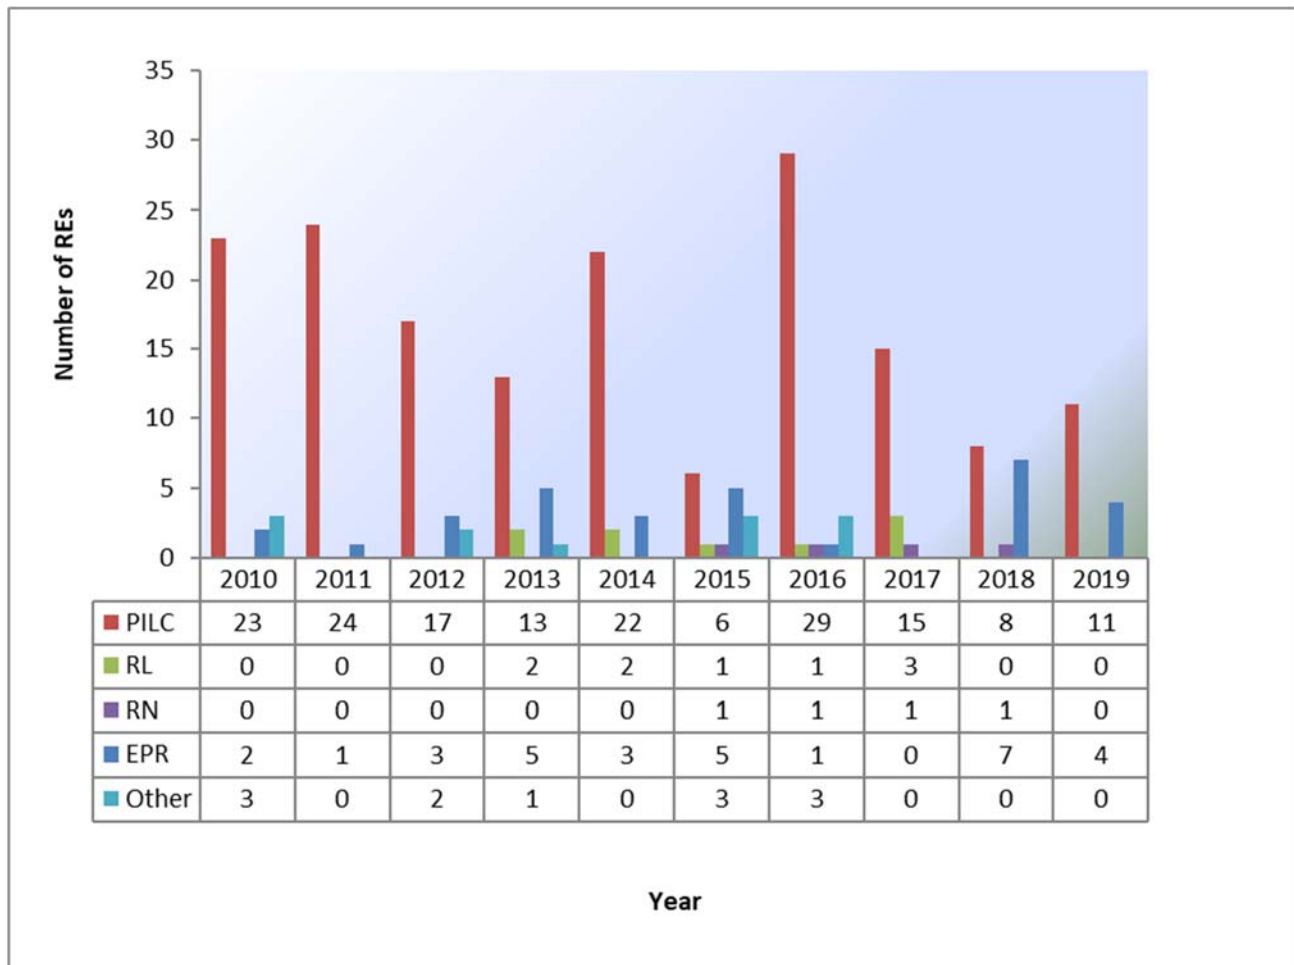
PILC is the predominant primary cable on the Pepco underground system. Consequently, most primary cable reportable events involve PILC cable (Figure 3.14).

Figure 3.14: Insulation Type of Primary REs (2010-2019)

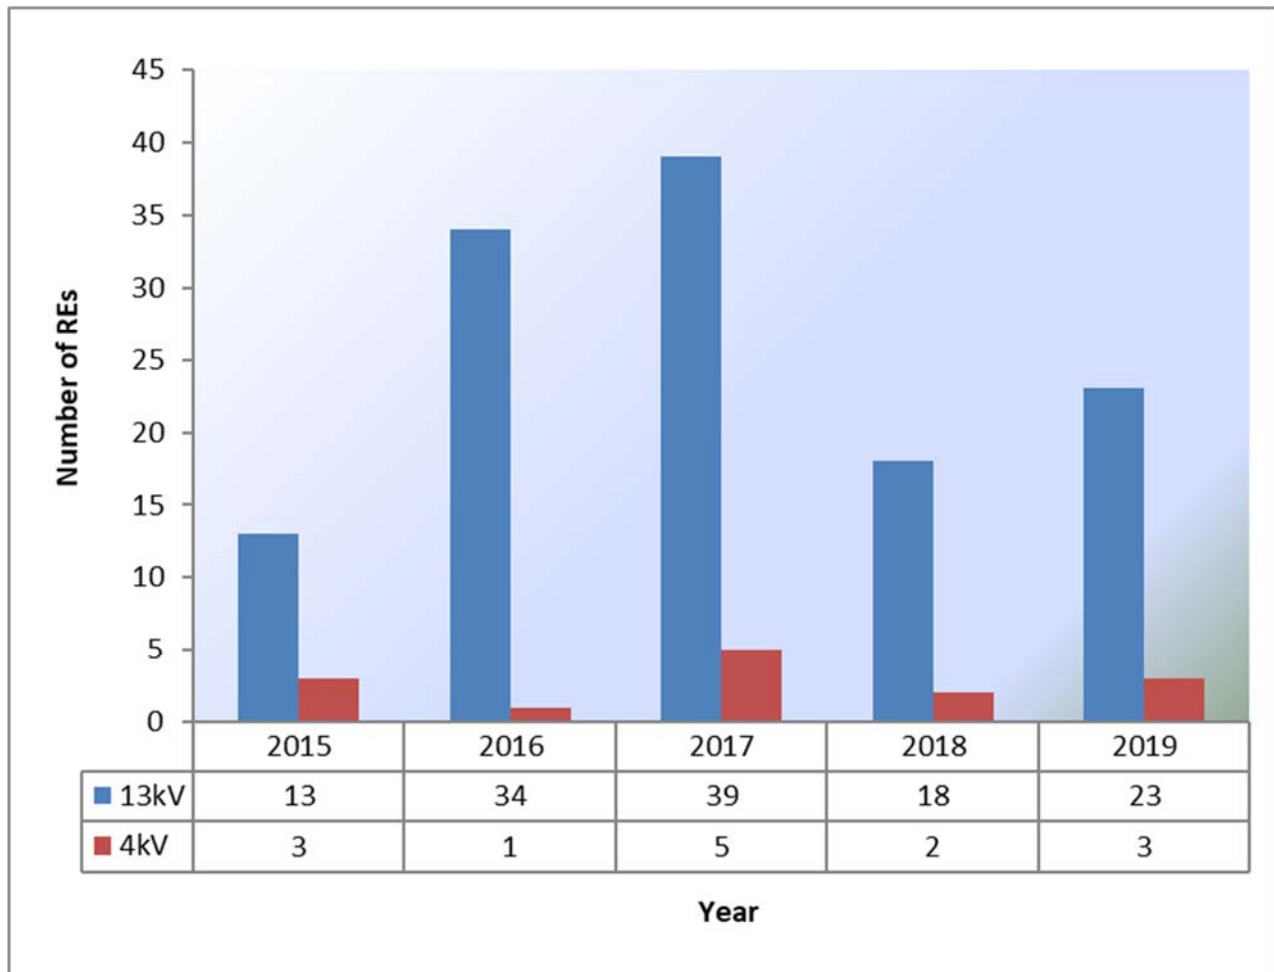
The majority of reportable events involving primary equipment occur on 13 kV feeders (Figure 3.15). 4 kV is a vintage technology and the majority of Pepco’s underground system is 13 kV.

Figure 3.15: Voltage Class of Primary REs (2015-2019)

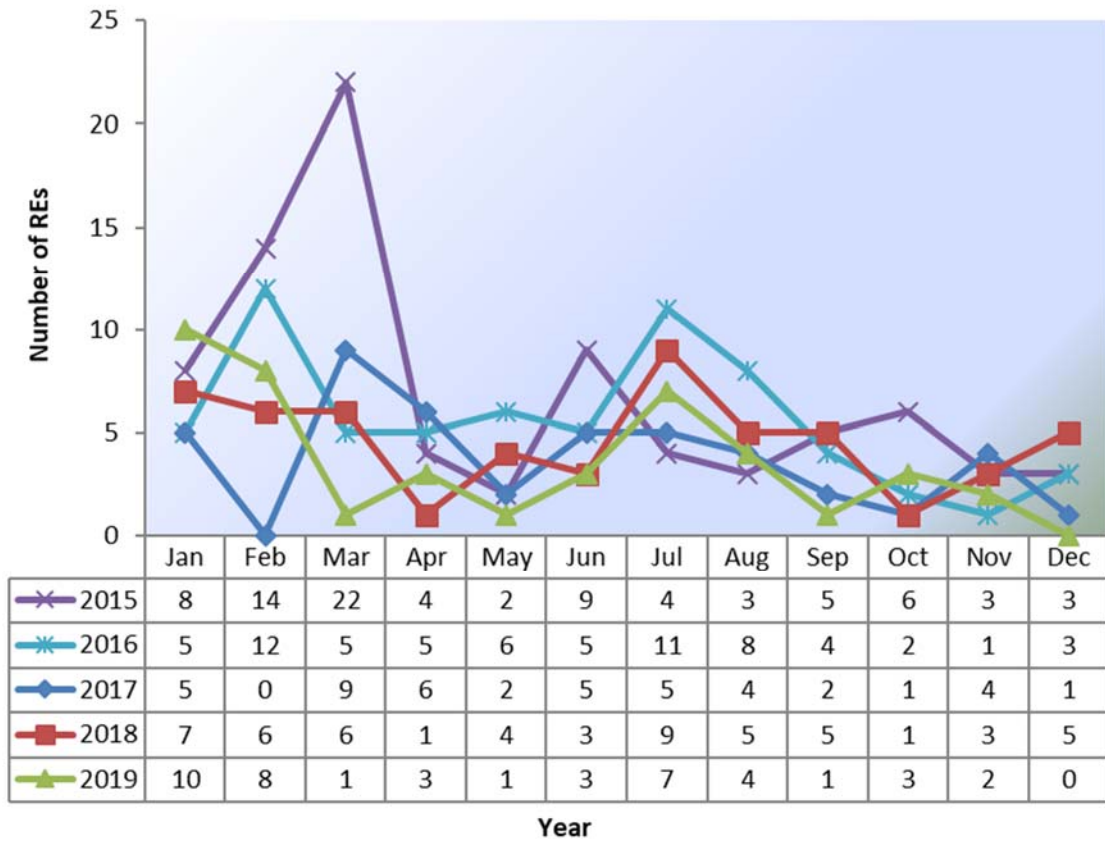
In addition, moisture plays a major role in the deterioration of both primary and secondary cable insulation. When a significant amount of precipitation is received in the District, moisture and contaminants from the street, such as motor oil, lawn chemicals, etc., enter into the manholes and affect cable insulation. Additionally, snow/ice melt chemicals ingress after a storm can also penetrate cable insulation and lead to failure. While moisture affects all cable insulation, since secondary cable is not as robust or of the same design as primary cable, secondary cable is inherently more likely to fail under adverse weather conditions. A comparison of Figures 3.16 and 3.17 suggests that total moisture accumulation affects the number of reportable events.

Figure 3.16: Reportable Events by Month (2015-2019)

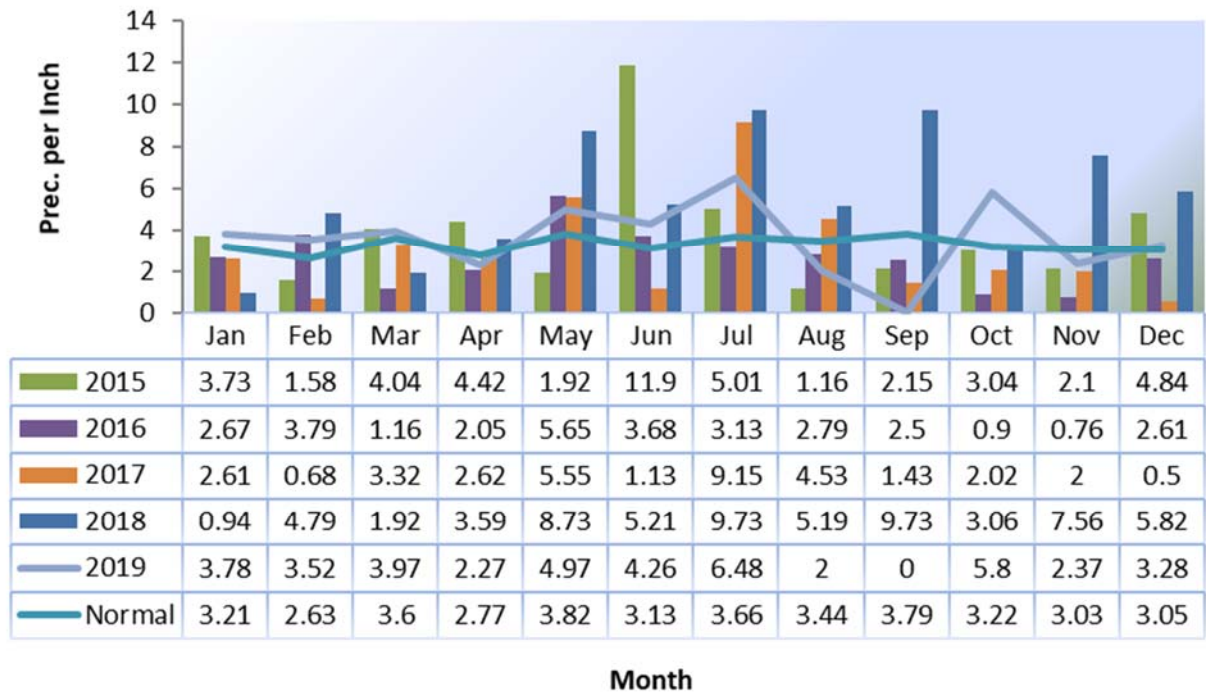
Figure 3.17: Total Precipitation in Inches by Month (2015-2019)

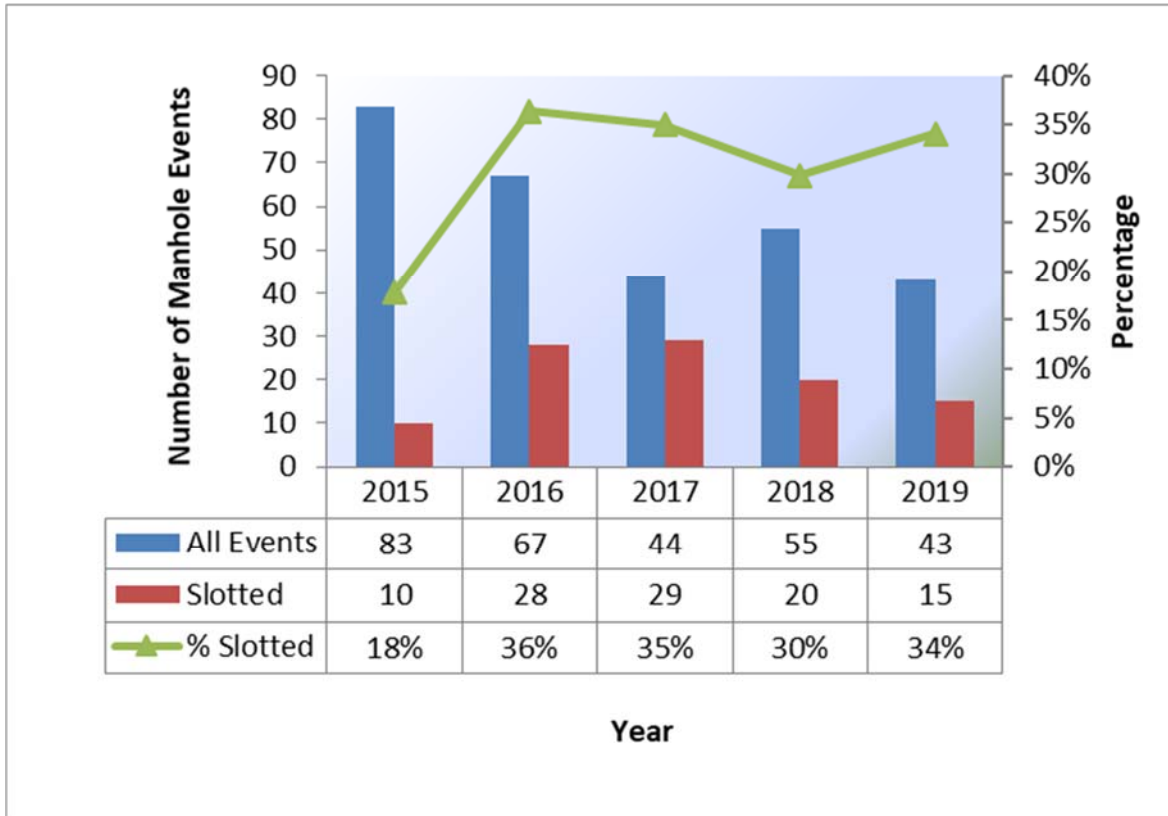
occurred in the District of Columbia in 2019, 15 involved manholes fitted with slotted covers. Over the five-year period from 2015 through 2019, there were 292 reportable manhole events. Of these, 102 (35%) occurred in manholes with slotted covers. See Figure 3.20.

Figure 3.20: Manhole Events Involving Slotted Covers

The rate of manhole events on these slotted covers is disproportional to the total population of these covers on the system. Currently there are slotted covers deployed on about 13% of manholes within the Pepco system yet we are consistently seeing slotted covers account for upwards of 34% of the total manhole events each year. This, coupled with the fact that the current Pepco designed slotted covers are not 100% ADA compliant has led Pepco to reconsider the design for vented manhole covers.

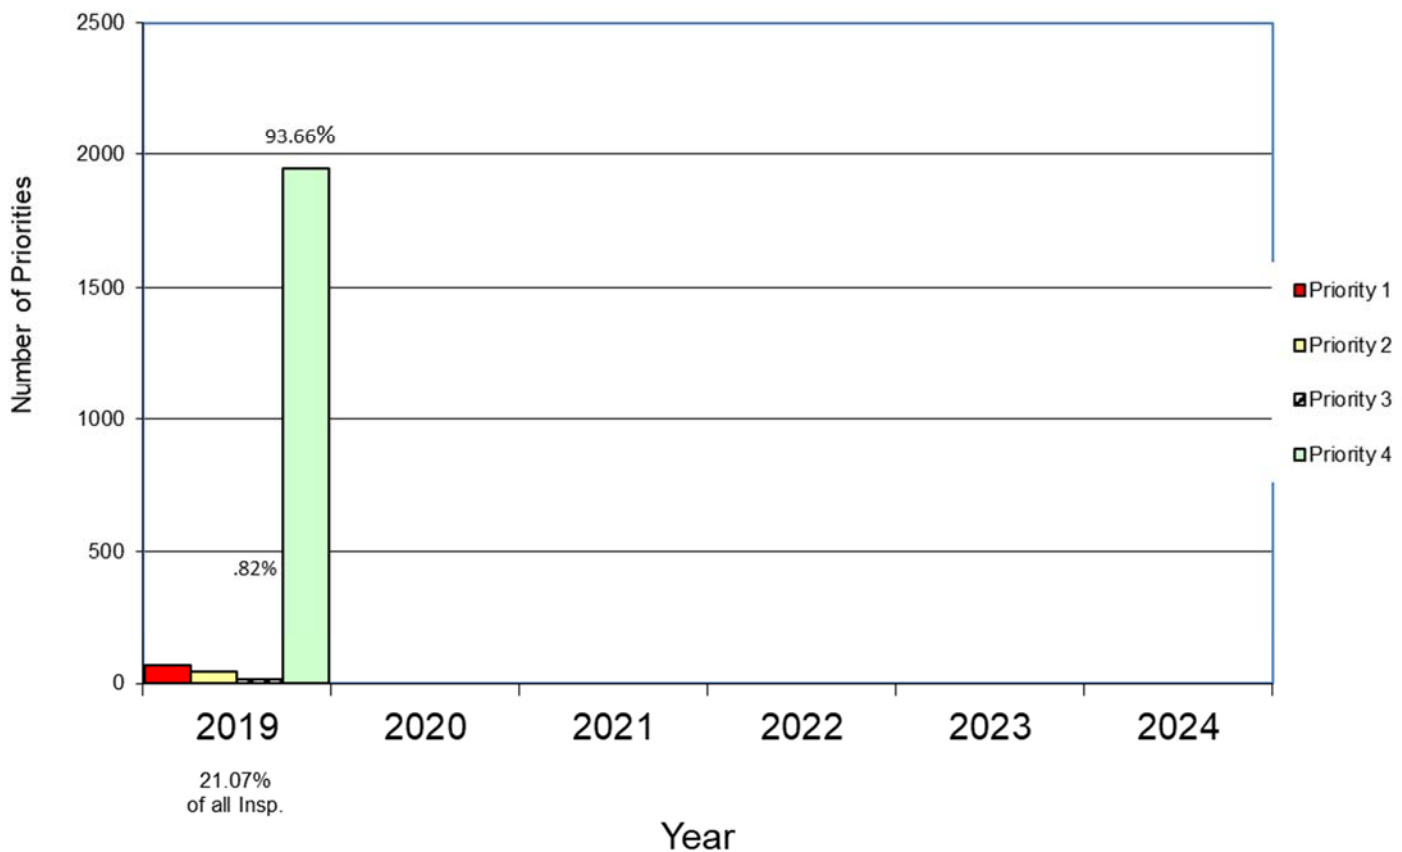
Inspectors are conducting more comprehensive and thorough inspections which have resulted in a substantial increase in Priorities found. In 2019, approximately 21% of the manholes inspected revealed potential areas of concern that have been or are in the process of being addressed. Figure 3.2-B1 provides a graphical representation of the number of manholes and the percentage of overall inspections with priority conditions during Phase IV.

Figure 3.2-B1: Manhole Inspection Priorities – Phase IV

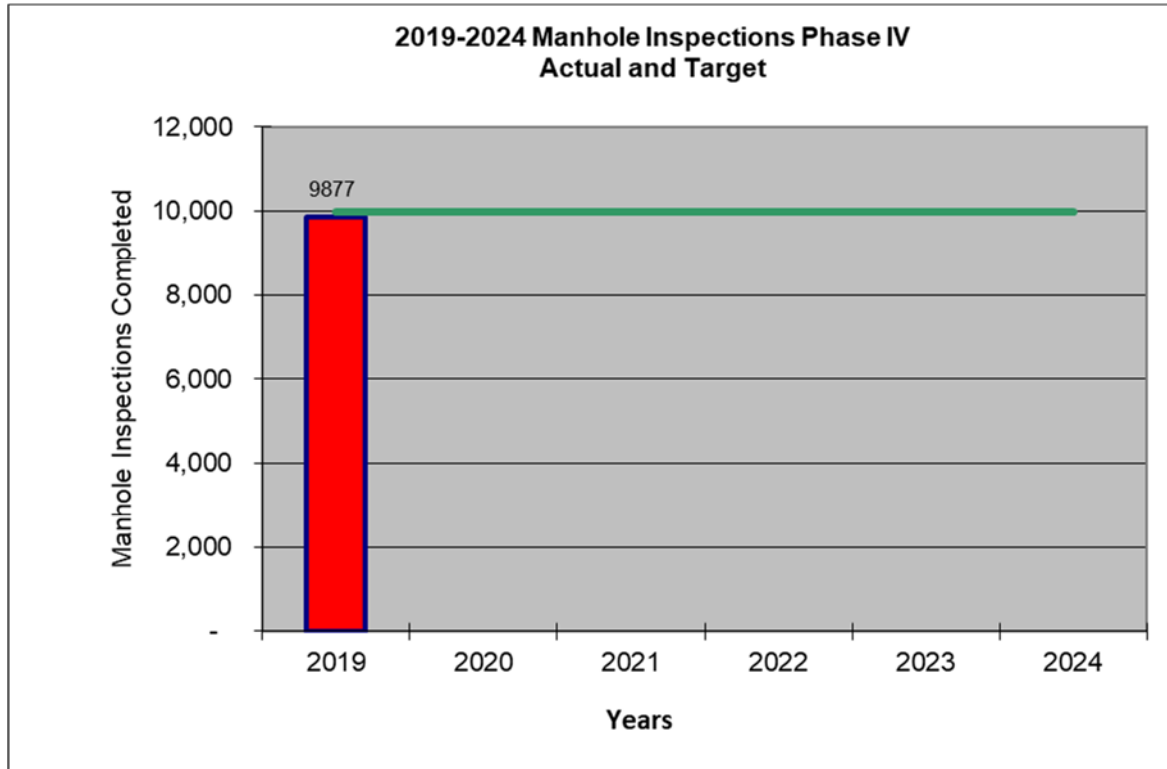
With the implementation of the Manhole Inspection Quality Control (QC) Program, inspection Priorities have increased from 155 in 2006 to 2,081 Priorities in 2019. The majority of the increase is related to Priority 4 conditions, which are not considered an imminent risk and must be remediated within 24 months.

Figure 3.2-B2: Manhole Inspections Completed – Phase IV

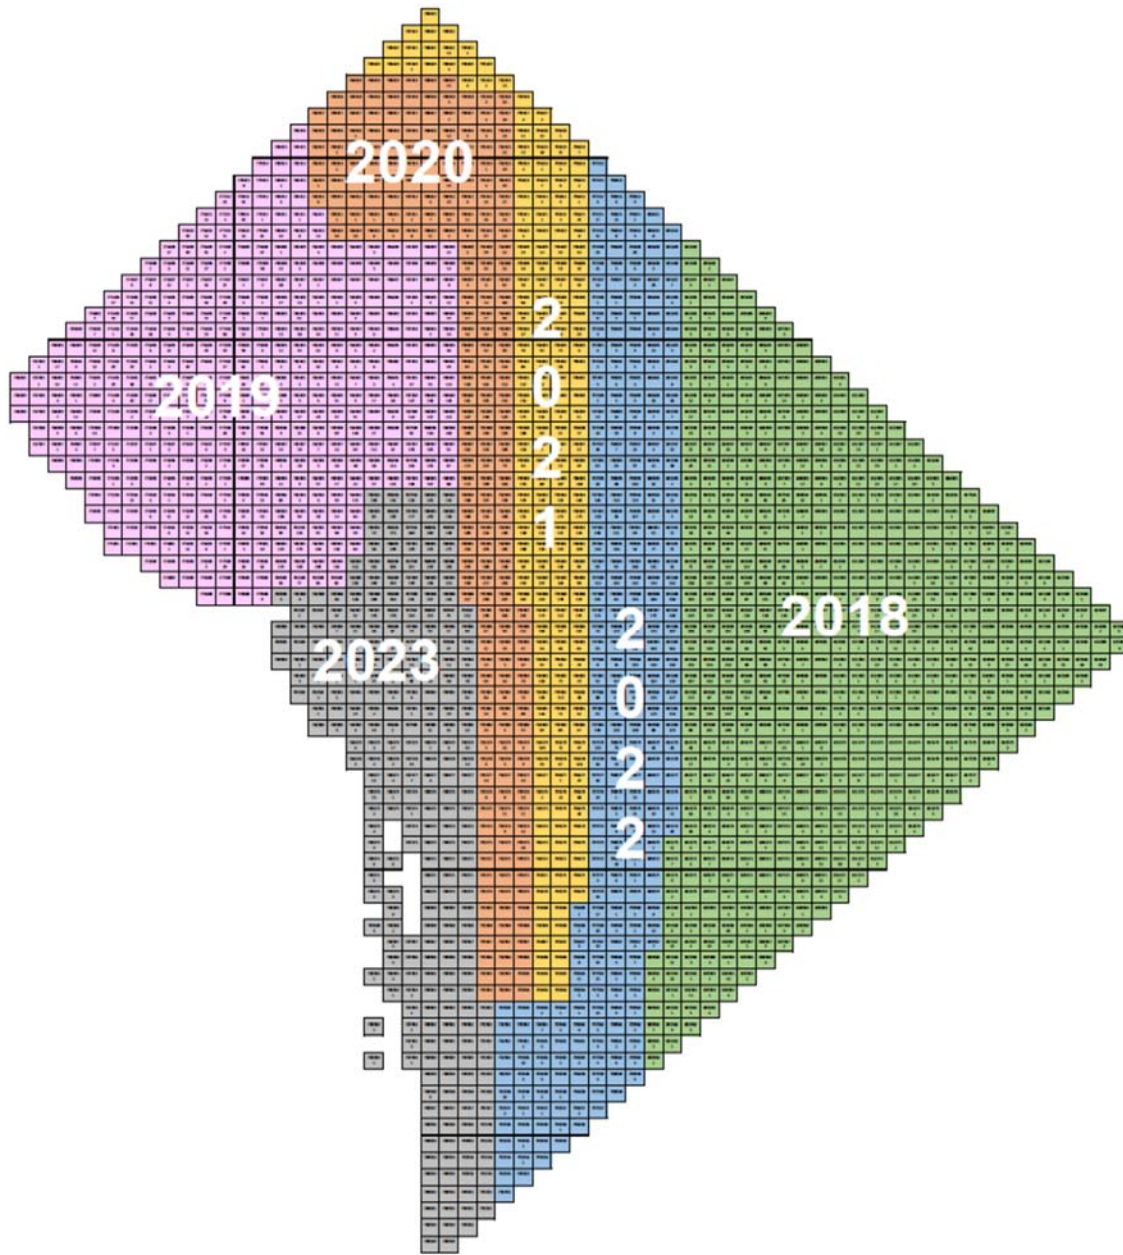
With the new GIS extract that was performed, a grouping of manholes based on geographic location was performed in order to solidify the inspection plan for the next 6 years. Figure 3.3 below shows the manhole inspection map of the District for years 2018-2023. Each colored region has an equivalent number of manholes within it, equally divided between 6 inspection years. This plan will improve the crew efficiency and future corrective maintenance work planning as crews won’t be moving all across the city during one year.

Table 3.3: 2018-2023 Manhole Inspection Plan

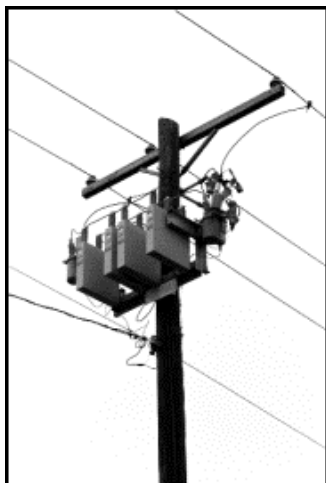
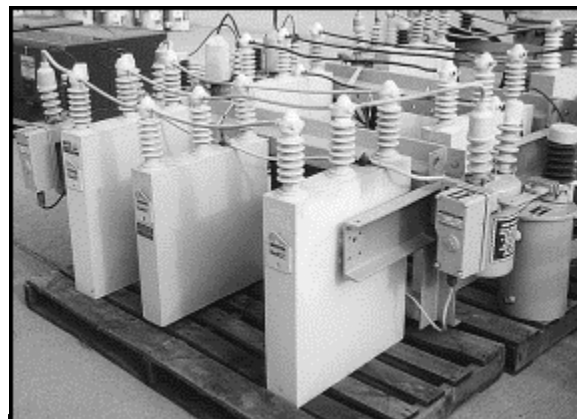
Capacitors

An electrical device for storing a charge of electricity and returning it to the line. It is used to balance the inductance of a circuit, since its action is opposite in phase to that of inductive apparatus; it throws the current ahead of the electromotive force in phase. It is made of alternate plates of tinfoil and insulating material. The size of plates and the thickness of insulating material determine the capacity for holding electric charge. Capacity is measured, practically, in micro-farads, millionths of a farad.

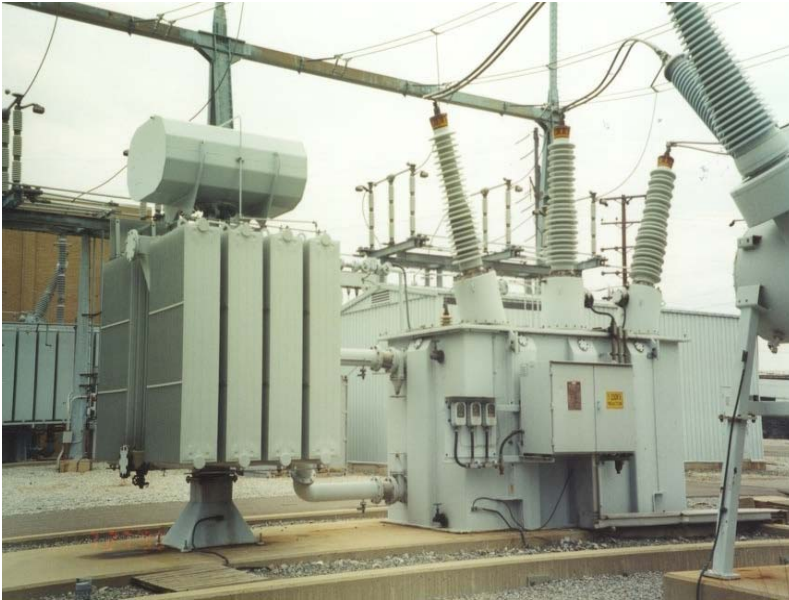
230 kV Reactor

A device, the primary purpose of which is to introduce reactance into a circuit.

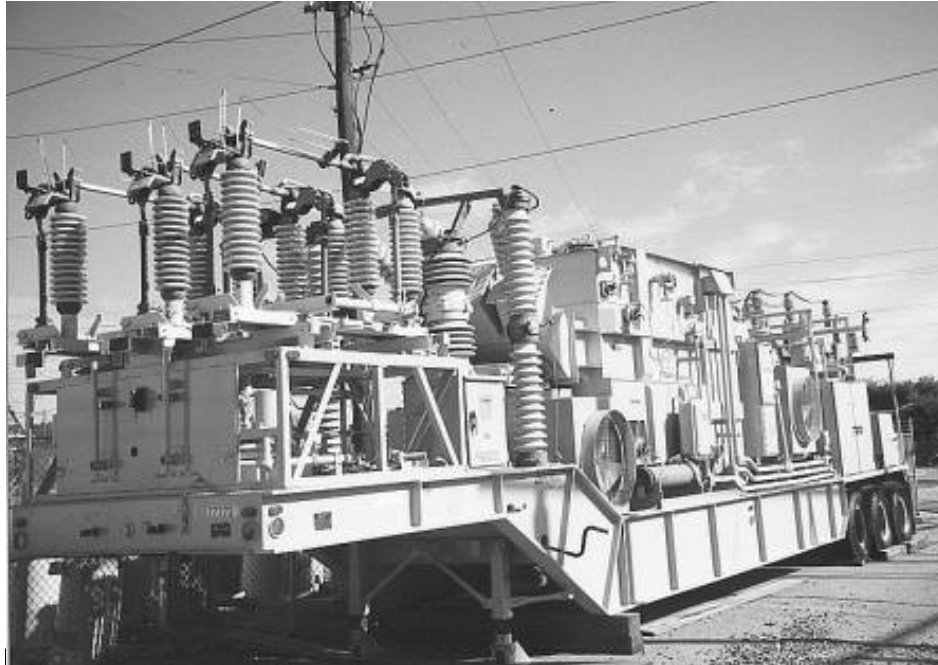
Mobile Substation

An assemblage of equipment for purposes other than generation or utilization, through which electric energy in bulk is passed for the purpose of switching or modifying its characteristics. Note: A substation is of such size or complexity that it incorporates one or more buses, a multiplicity of circuit breakers, and usually is either the sole receiving point of commonly more than one supply circuit, or it sectionalizes the transmission circuits passing through it by means of circuit breakers.

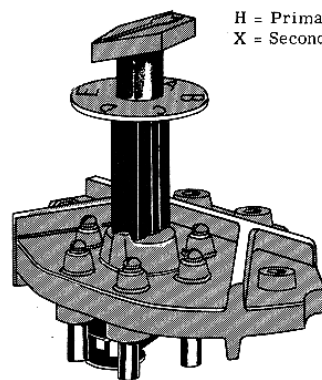
No Load Tap Changer

A Tap Changer is Used to Adjust the Turns Ratio of a Transformer

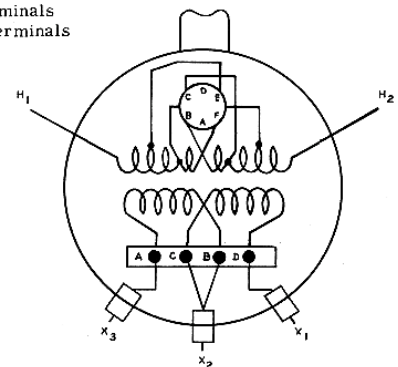
Connections that allow a transformer’s turns ratio to be adjusted by adding turns to or subtracting turns from the transformer’s primary or secondary winding. A connection brought out of a winding at some point between its extremities to permit changing the voltage or current ratio (general). An intermediate point in an electric circuit where a connection may be made.

H = Primary Terminals
X = Secondary Terminals

Typical Internal Wiring of Transformer with Tap Changer

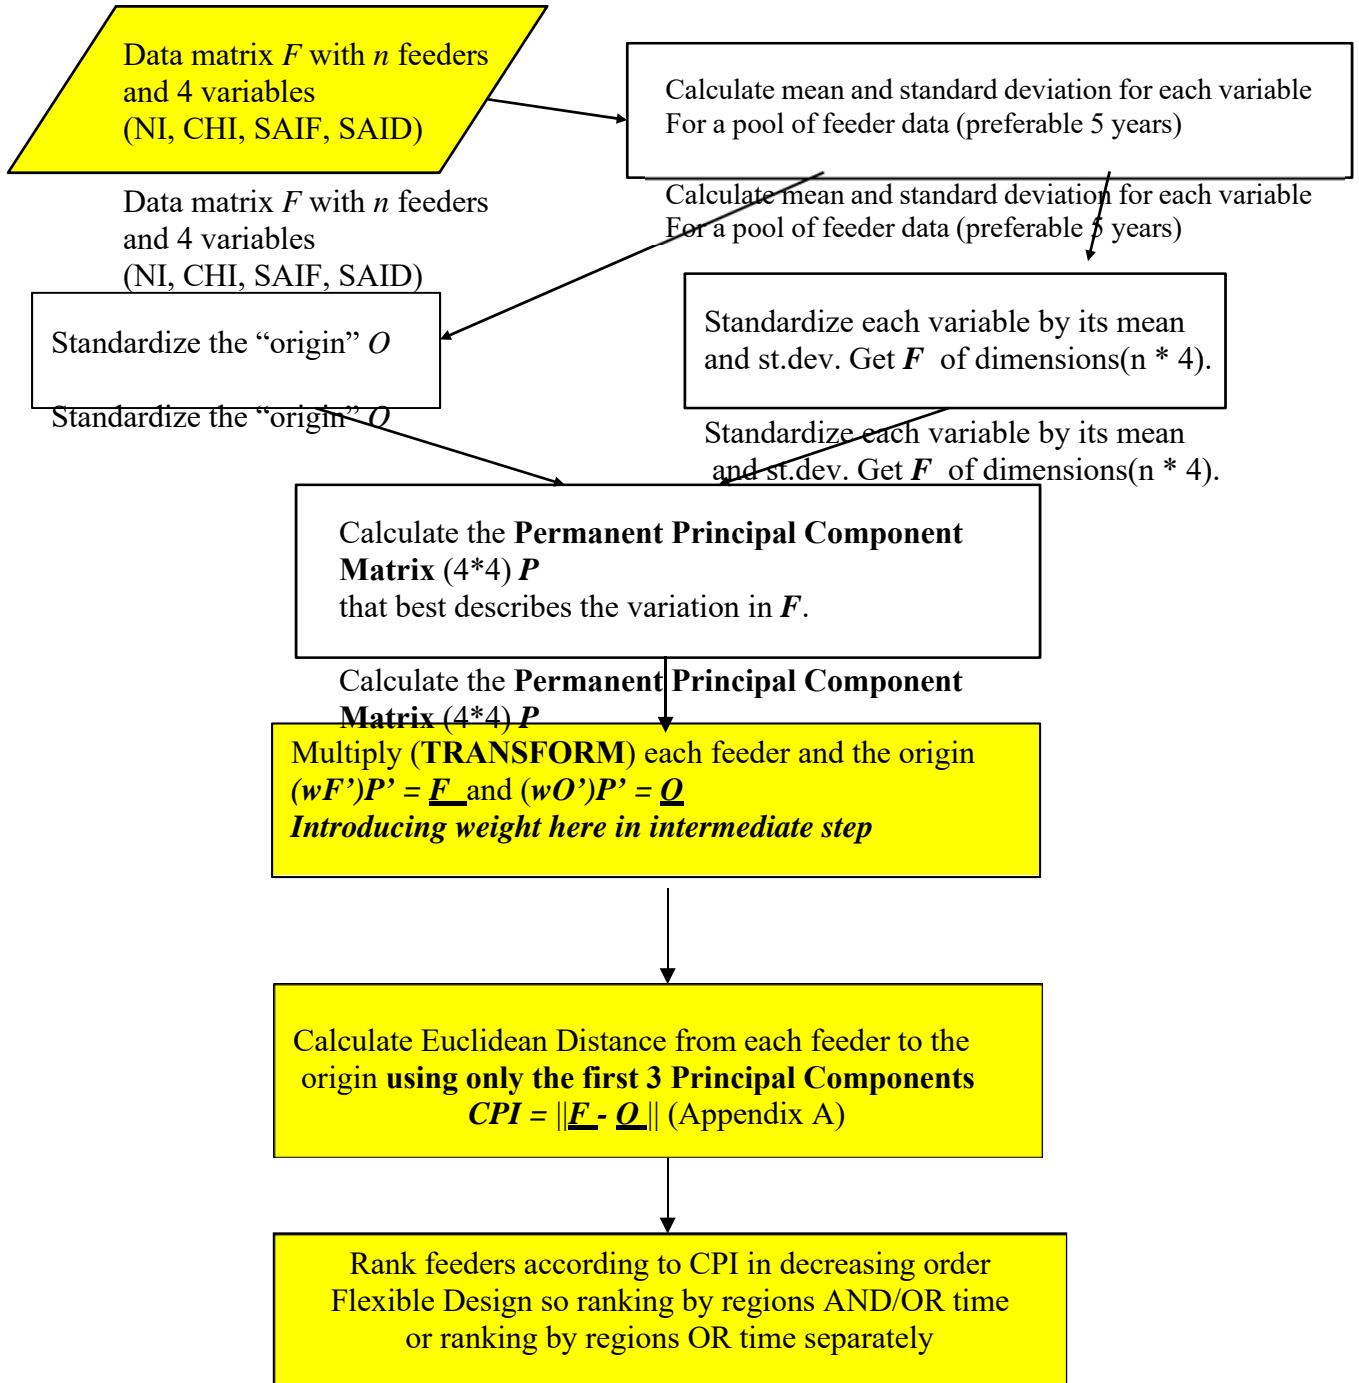
The following flow chart (Figure 4.4-B) illustrates the process for calculating the Composite Performance Index for a feeder.

Figure 4.4-B -- Illustration of CPI Concept
