Attached please find Potomac Electric Power Company's 2021 Annual Consolidated Report. In addition, per Order No. 20203, Pepco has included Attachment F, which provides required information related to the Downtown Resupply Project.

## **2021 CONSOLIDATED REPORT**

POTOMAC ELECTRIC POWER COMPANY

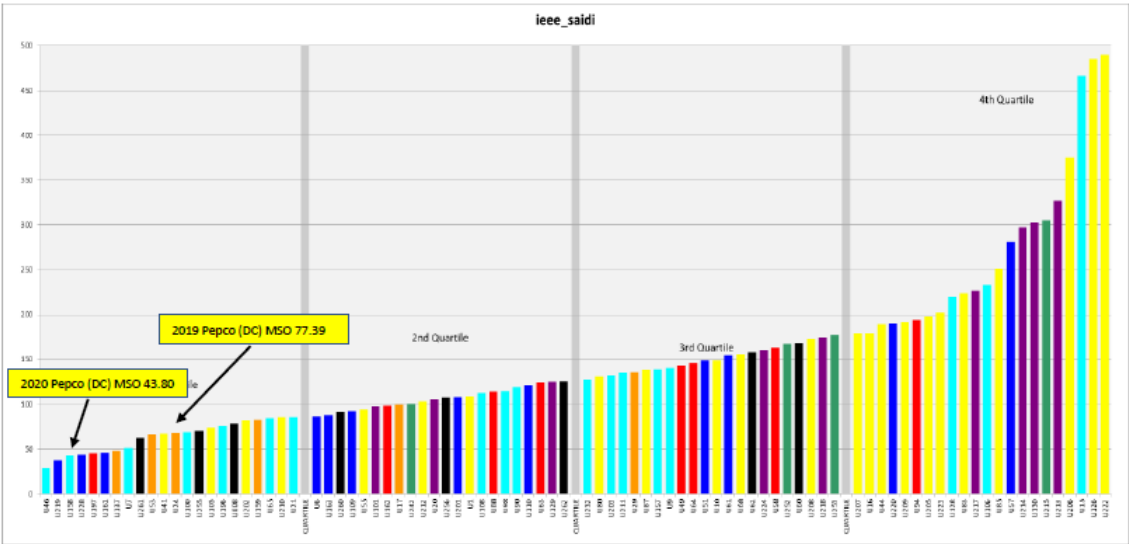
Figure 1.3-B

Major Event Excluded (IEEE SAIDI 2020)

The Industry Comparisons section contains industry comparisons of transmission and distribution operations and performance. The comparisons of reliability indices are provided in Figures 1.3-A through 1.3-C in response to Commission directives in Formal Cases No. 766 and 982.

Each year, Pepco participates in the annual Transmission and Distribution System Benchmarking Study conducted by IEEE. Although Pepco's District of Columbia service territory did not participate separately in the study, the Company has calculated separate values for Pepco's District of Columbia territory in both 2019 and 2020, using the MSO reporting criteria and has indicated both of these reliability results on the following charts. Note that Pepco's 2020 reliability results that are reported in the following graphs are not directly comparable to the data used in the 2019 study. See Figure 1.3-A through Figure 1.3-C.

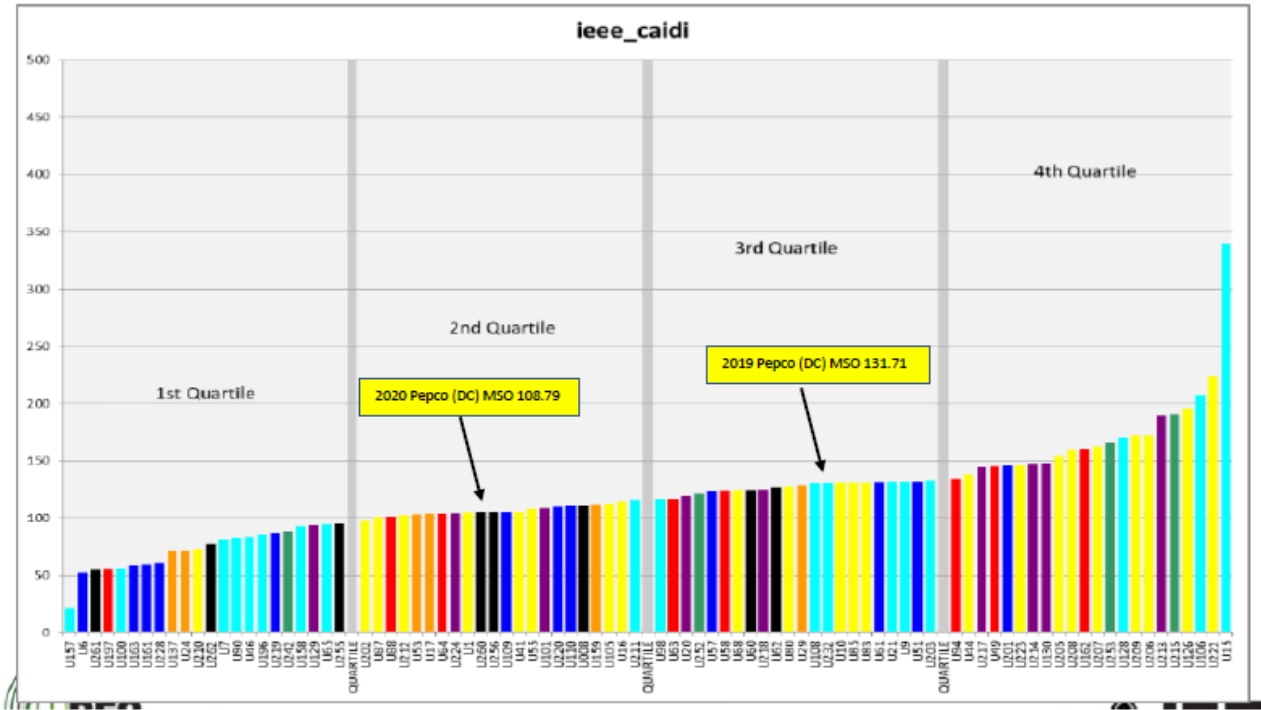
Figure 1.3-C

Major Event Excluded (IEEE CAIDI 2020)

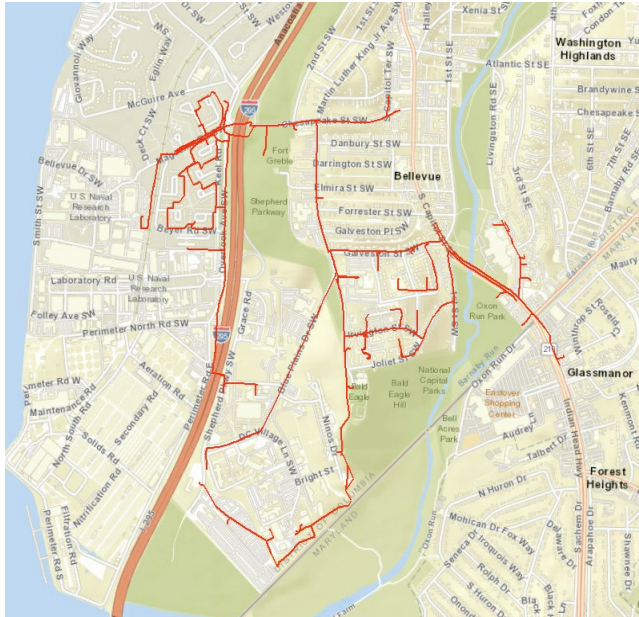
**Feeder Map and Location:**

<u>Served</u>	<u>Outages</u>	<u>(In Hours)</u>						<u>Last 2 Years?</u>
				<u>SAIFI</u>	<u>SAIDI</u>	<u>CAIDI</u>	<u>OH</u>	<u>UG</u>	<u>Total</u>	
DC	Nrl (168)	2,169	19	1.361	93.3	68.6	66%	34%	10.08	N

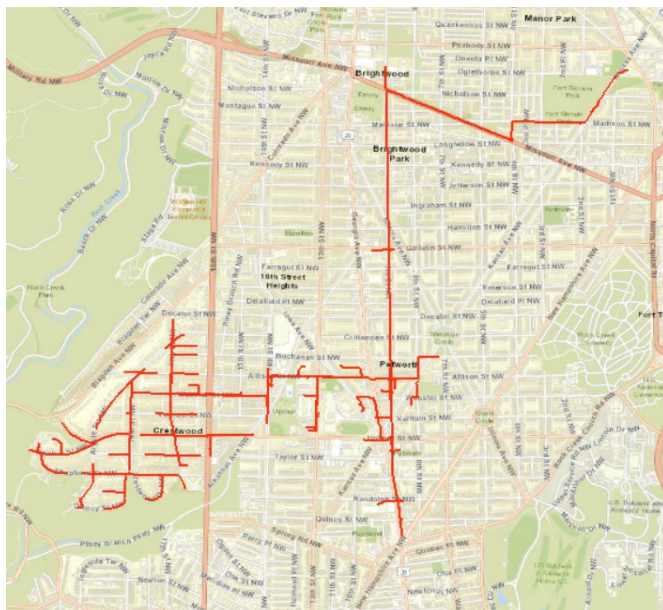
**Feeder Map and Location:**

County	Substation	Customers Served	Number of Outages	Oct. 2019-Sept. 2020 Reliability Indices (In Hours)			Feeder Miles			Repeated Last 2 Years?
				SAIFI	SAIDI	CAIDI	OH	UG	Total	
DC	Ft. Slocum (190)	1,300	11	1.79	174	96.6	65%	35%	12.16	N

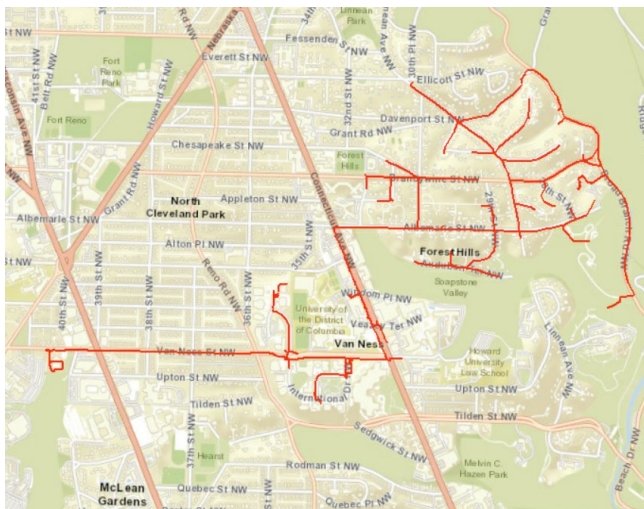
**Feeder Map and Location:**

County	Substation	Customers Served	Number of Outages	Oct. 2019-Sept. 2020 Reliability Indices (In Hours)			Feeder Miles			Repeated Last 2 Years?
				SAIFI	SAIDI	CAIDI	OH	UG	Total	
DC	Van Ness (129)	322	21	1.86 <sup>6</sup>	203	108.9	59%	41%	7.23	N

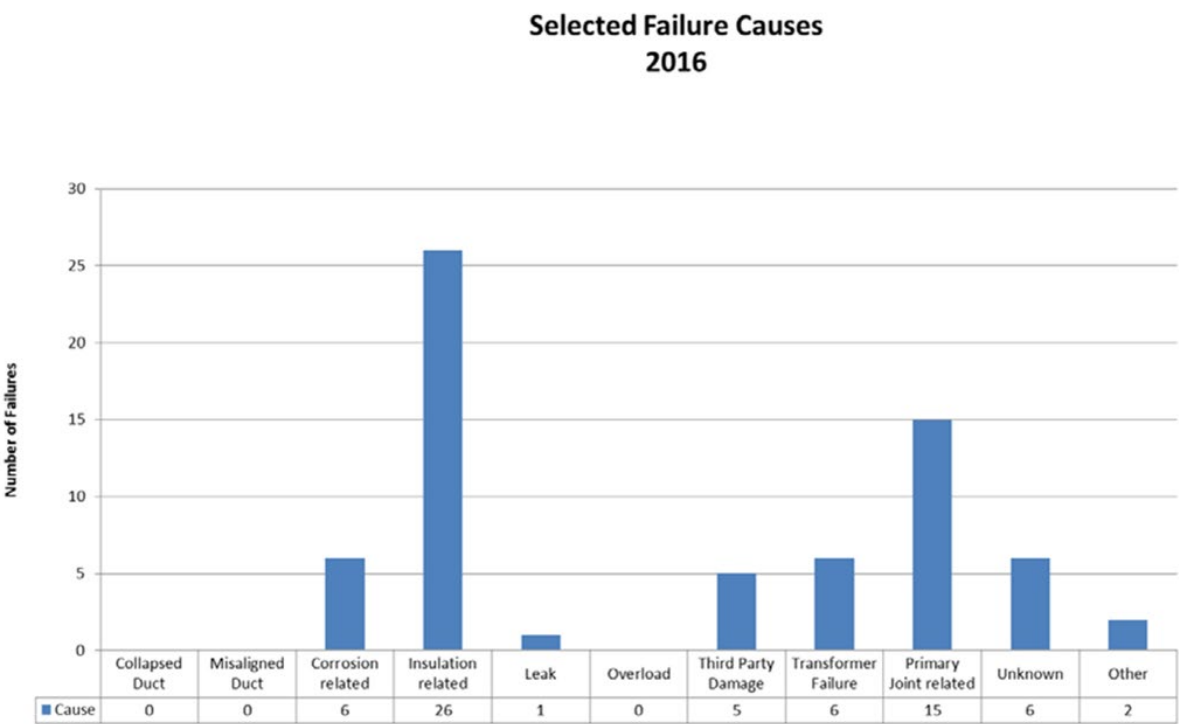
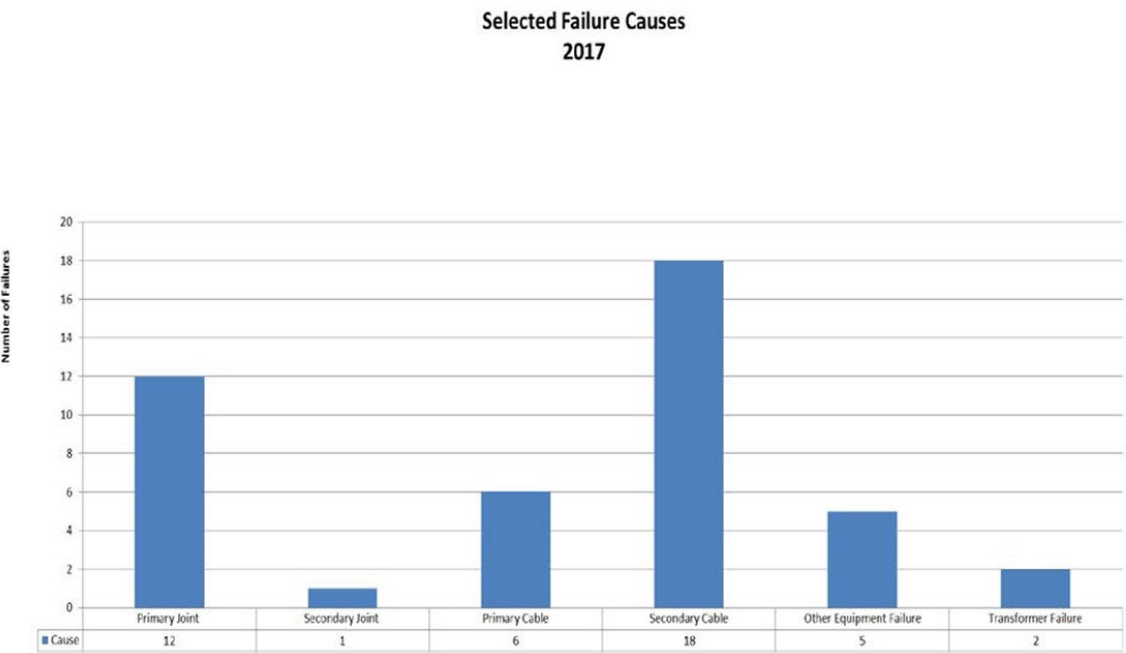
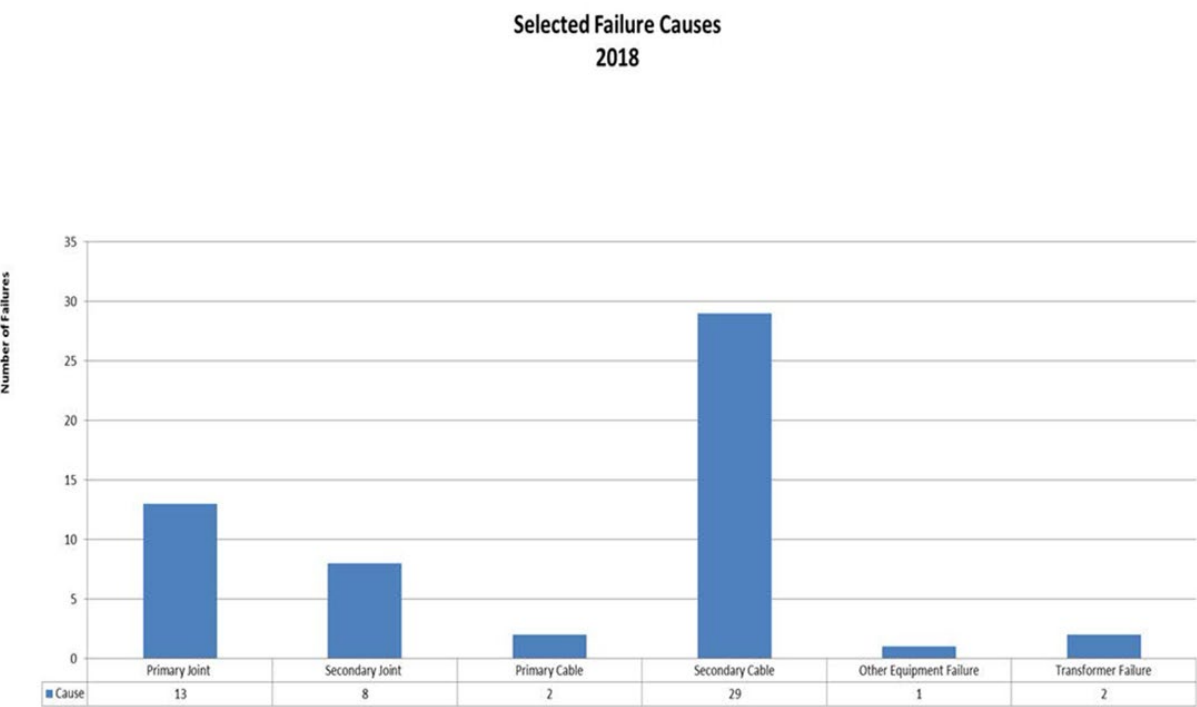
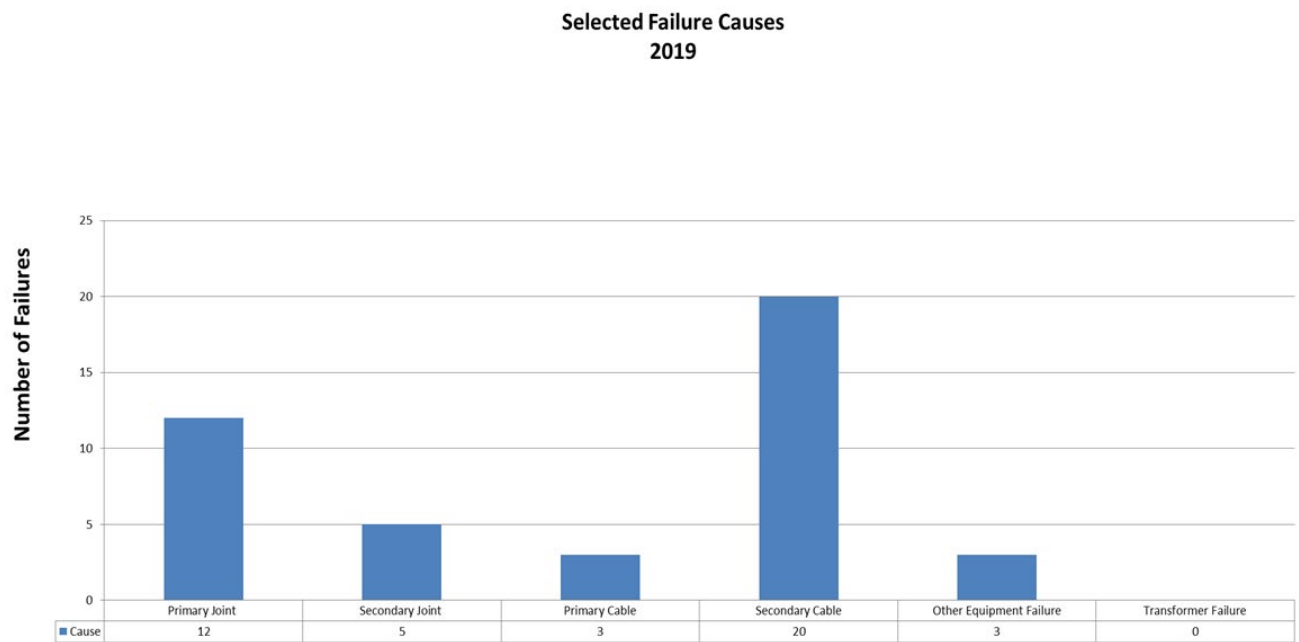
By design, primary cable is more insulated than secondary cable. Whereas primary cable and its accessories are designed to their voltage rating and are shielded, secondary cable and its accessories are not shielded. As a result of less physical protection, secondary cable and its accessories are more likely to fail due to a breach in the insulation. Since 2016, the leading cause of manhole reportable events in the District is insulation-related, such as insulation deterioration. See Figures 3.10 through 3.14.

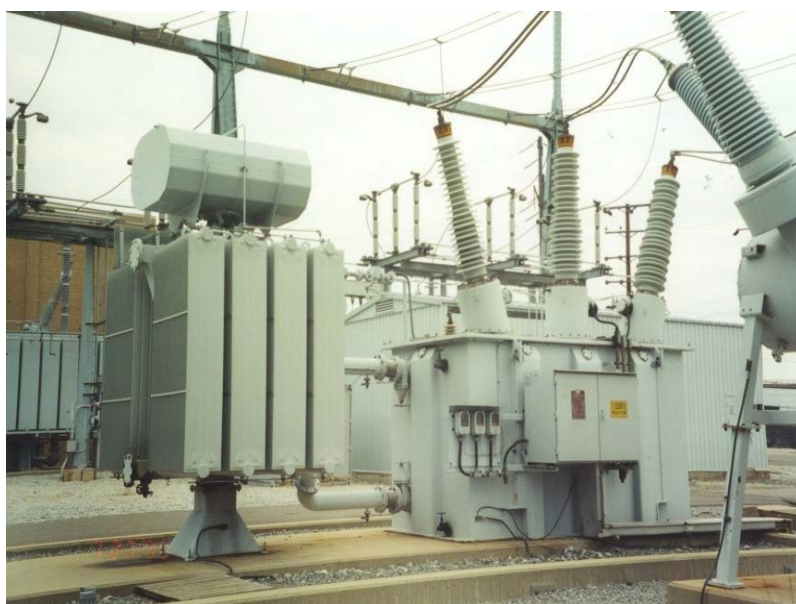
**230 kV Reactor**

A device, the primary purpose of which is to introduce reactance into a circuit.

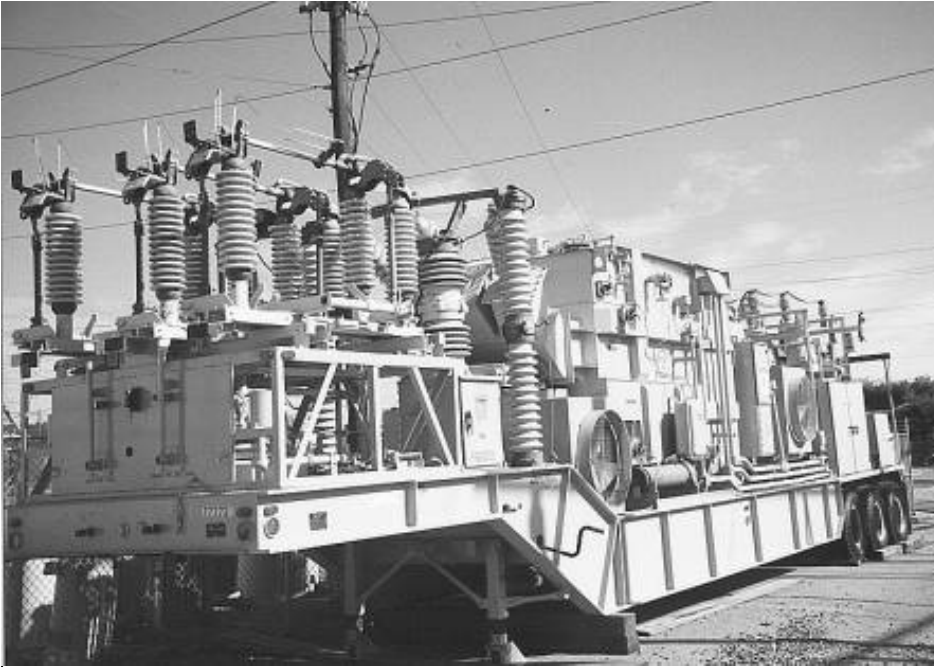
**Mobile Substation****Switchgear**

An assemblage of equipment for purposes other than generation or utilization, through which electric energy in bulk is passed for the purpose of switching or modifying its characteristics. Note: A substation is of such size or complexity that it incorporates one or more buses, a multiplicity of circuit breakers, and usually is either the sole receiving point of commonly more than one supply circuit, or it sectionalizes the transmission circuits passing through it by means of circuit breakers.
